**MARINE INVESTIGATION REPORT  
M10F0003**

**KNOCKDOWN AND CAPSIZING**

**SAIL TRAINING YACHT *CONCORDIA*  
300 MILES SSE OFF RIO DE JANEIRO, BRAZIL  
17 FEBRUARY 2010**

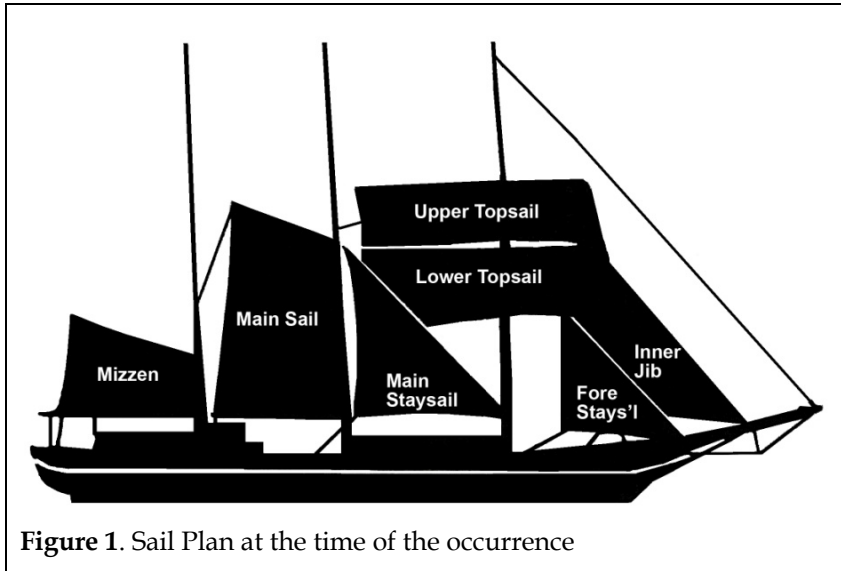
Figure 1. Sail Plan at the time of the occurrence

On the morning of 17 February 2010, in anticipation of the expected weather, the master shortened sail, culminating in the following sail plan at the end of his watch (1200): inner jib, fore staysail, upper and lower topsails, main staysail, main, and reefed mizzen sails (see Figure 1).<sup>12</sup> The 2/O, whose watch was from 12 to 4,

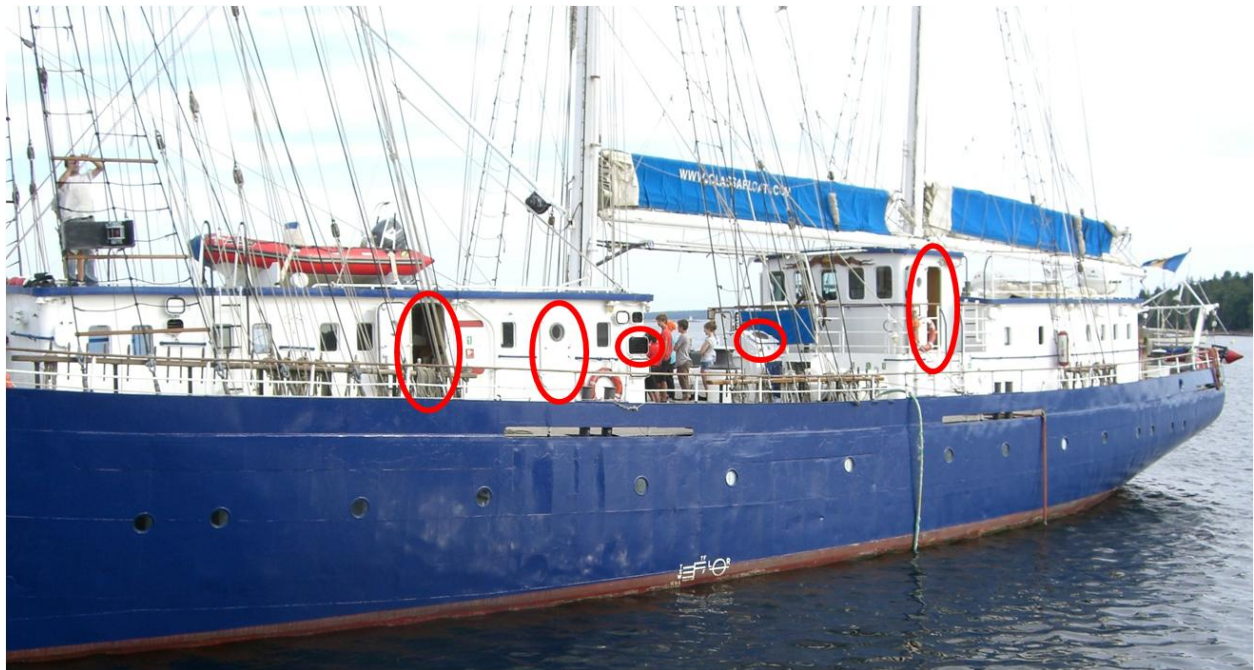
**Photo 3.** Some critical port side openings

Note: Immersion of these openings would lead to downflooding of the hull.

Circled from forward to aft: mess room door, galley door, sanitary exhaust vent, engine room skylight and wheelhouse door.

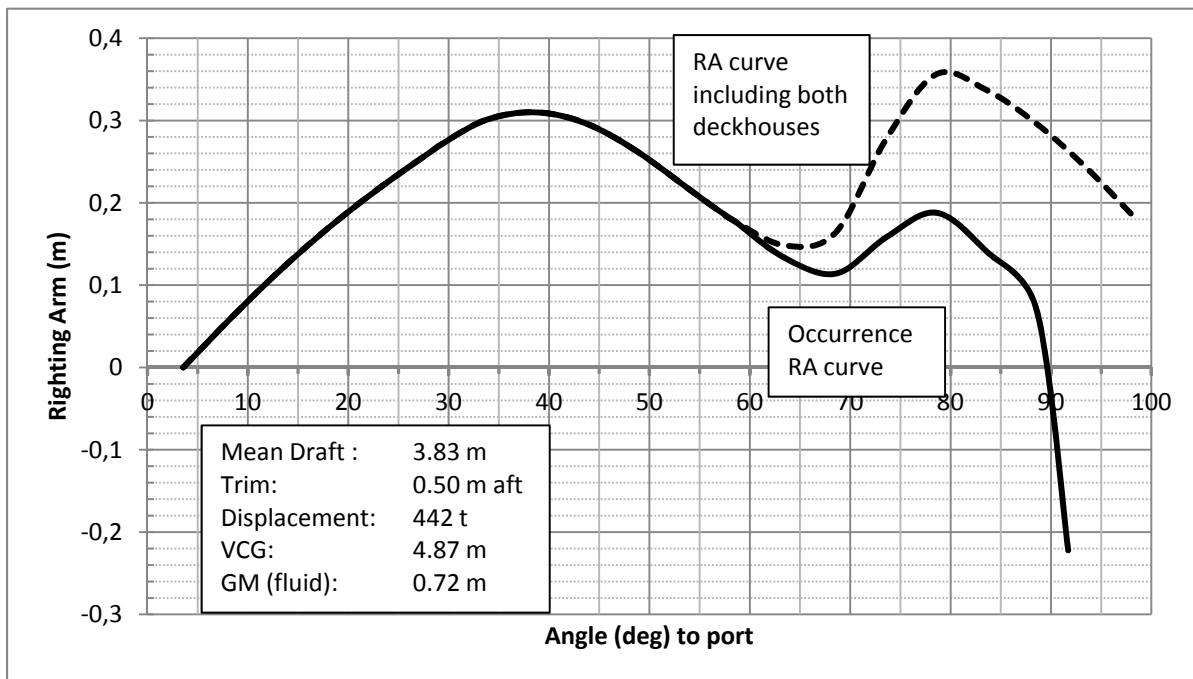
**Figure 5.** Occurrence righting arm (RA) curve<sup>63</sup> showing the effect of lost buoyancy from the deckhouses

The RA curves presented in *Concordia's* stability booklet are based on the assumption that the weathertight doors in the 2 deckhouses are secured closed, and thus that the deckhouses contribute to the vessel's buoyancy. The resulting effect on the vessel's righting ability can be seen as a second 'bump' in the RA curve beyond angles of around 60° (see Figure 5).

As mentioned previously, the deckhouse doors on the port side were open at the time of the occurrence. The resulting effect on the vessel's righting ability was modelled by eliminating the buoyancy contribution of the relevant deckhouse beyond those angles which would immerse its door(s) as shown in Table 3—the forward deckhouse was discounted after about 58 degrees and the aft deckhouse after about 88 degrees. The RA curve at the time the occurrence was thereby derived and is shown in Figure 5 below.

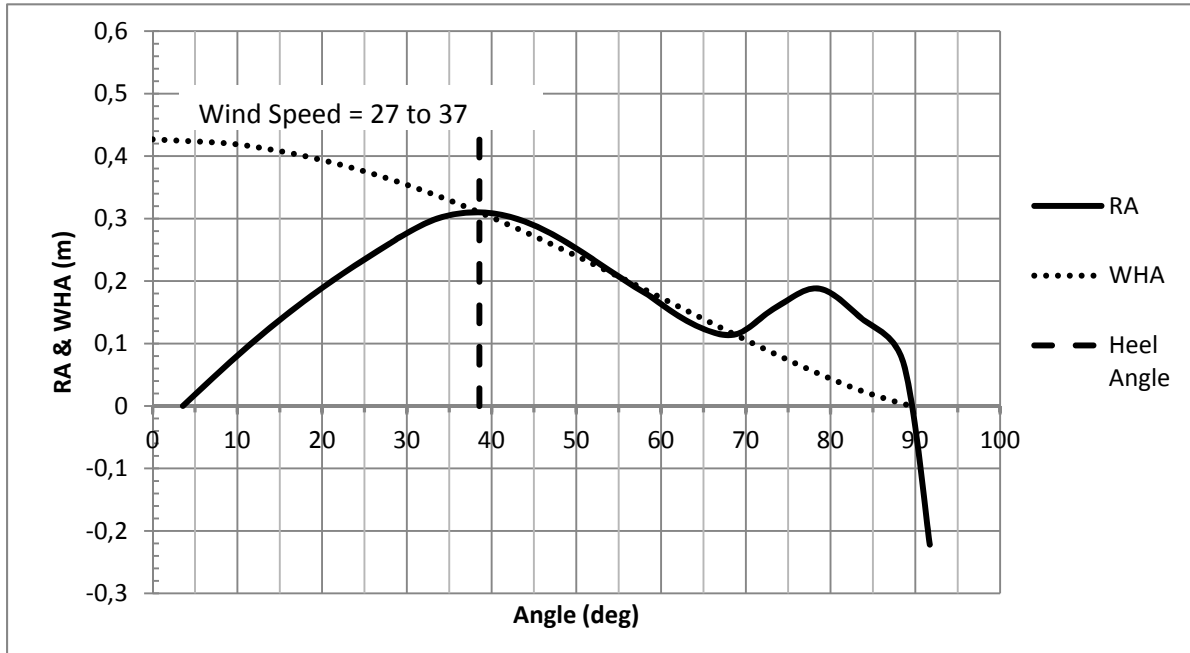
Figure 6. Occurrence righting arm (RA) / wind heeling arm (WHA) curves

It can also be seen in Appendix G that to induce wind heel angles beyond 70° or so, the necessary apparent wind speeds increase significantly to the point where winds in excess of 60 knots would be required to knock the vessel down to an angle in the range of 80°.

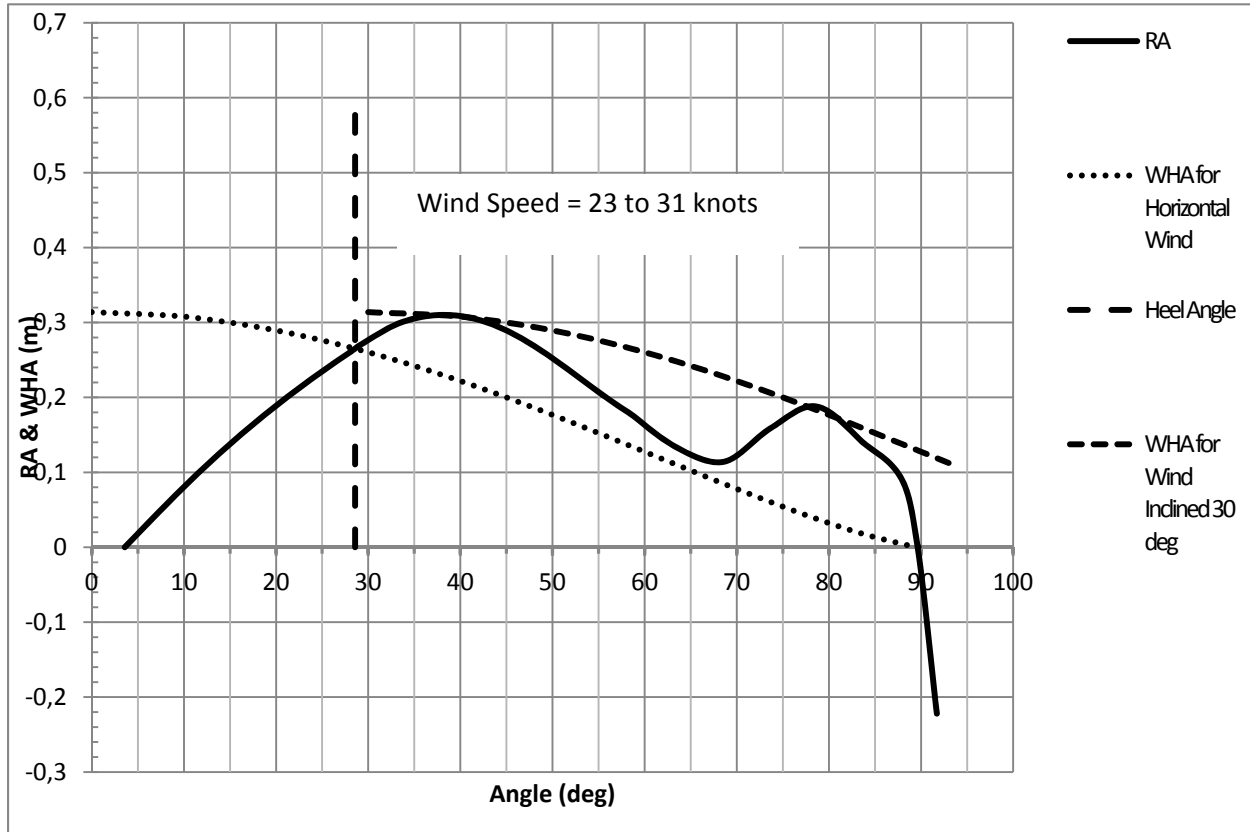
Figure 7. Wind heeling arm curve for wind inclined 30 ° from the horizontal

Figure 7 demonstrates this effect on the *Concordia's* righting ability. First, it is assumed that the vessel is heeled to an angle around 28° due to a horizontal wind. According to the relationship between apparent wind speed and heel angle shown in Appendix G, horizontal winds of between 23 and 31 knots would be sufficient to induce this heel angle. Then, the heeling arm curve is shifted 30° to the right, assuming the winds have shifted to 30° from the horizontal. As can be seen in Figure 7, the vessel's righting ability would be completely overcome by this combination of wind speed and inclination.

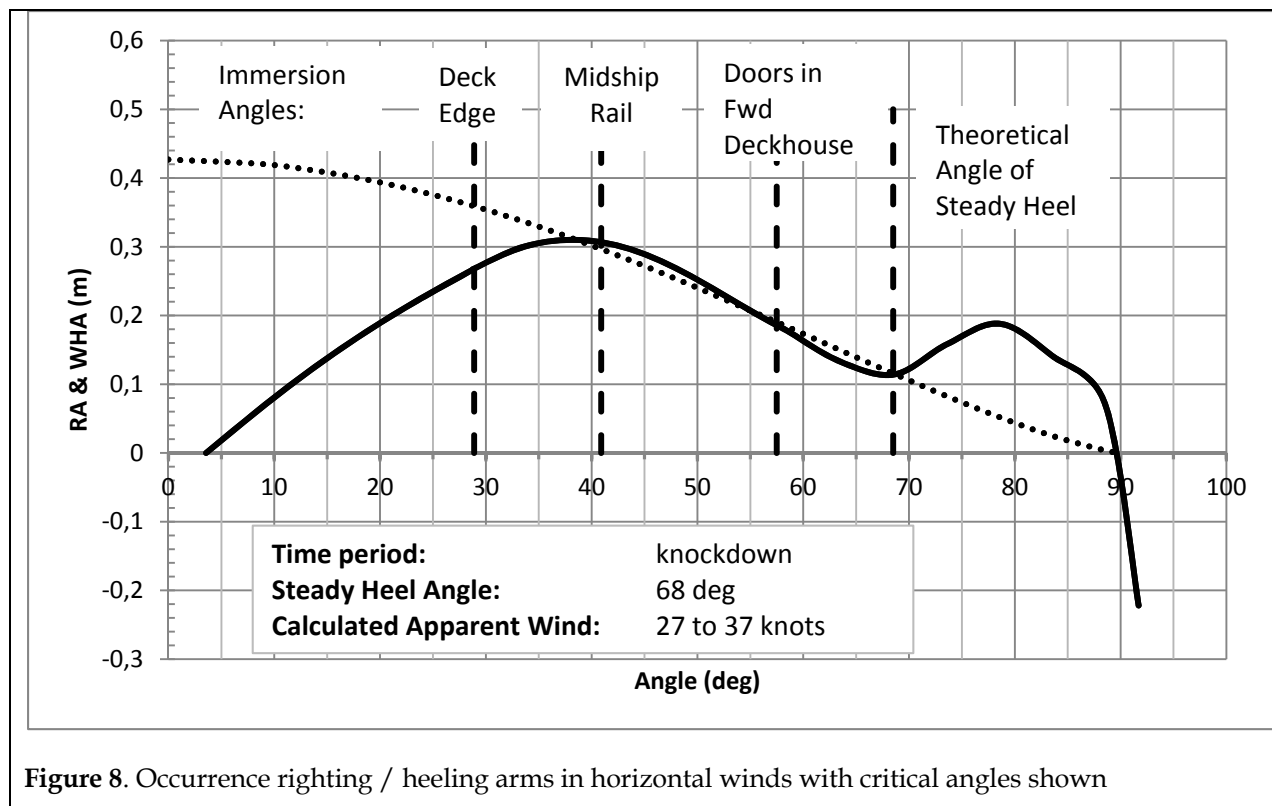
As Figure 8 indicates, although the vessel would theoretically take up a steady heel angle of almost 70° in such winds, water would have begun entering at various critical points before that angle was reached – first, via the open doors in the forward deckhouse (56.5°), then shortly thereafter via the sanitary exhaust vent, which was just aft of that (65°). With all of the doors on the port or lee side, as well as the ventilators and engine room skylight in the open position at the time of the knockdown, there was nothing to prevent or mitigate the downflooding that followed, progressing until the vessel ultimately lost all stability, rolled over, and capsized. The vessel’s ability to recover would have been further hindered by the weight of water entrained in the sails as they submerged, in addition to the possible shifting of weights/equipment.

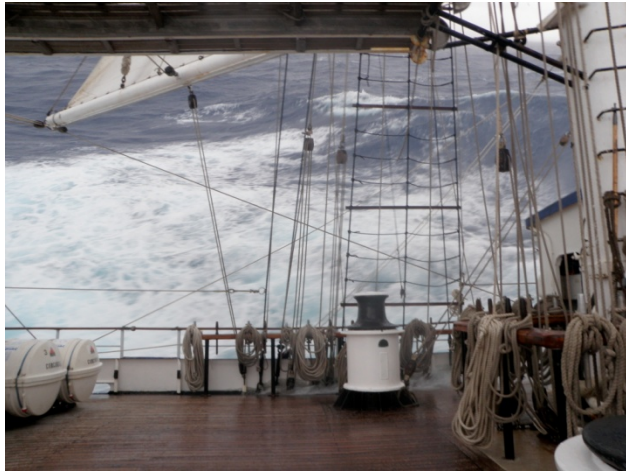
**Photo 4.** Port deck edge immersed at 29°

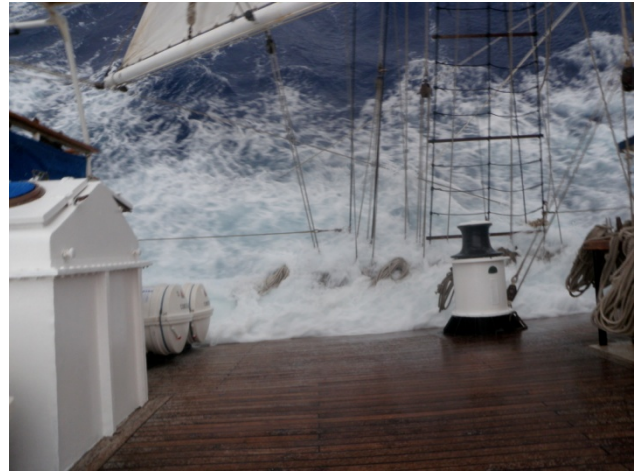
**Photo 5.** Port rail immersed at 41°
