Barbados maritime ship registry

M.V. Fluvius Tamar
IMO Number 9501708

**Report of the investigation into the Loss of the
Fluvius Tamar, while on passage from
Eemshaven to Pasajes.**

Issue by: 31st August 2017

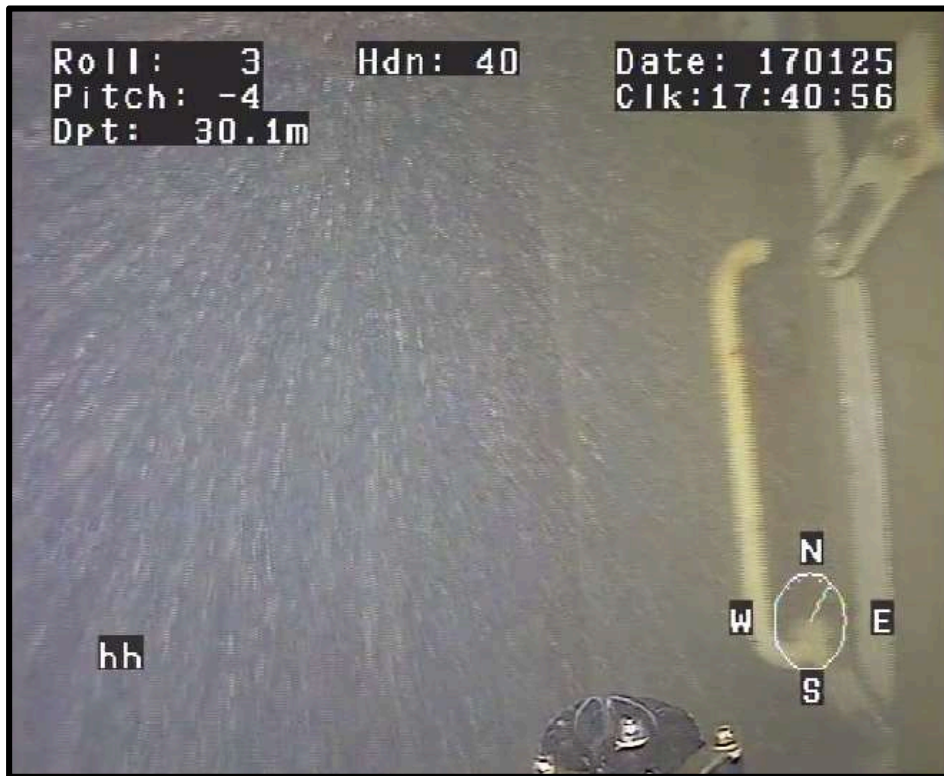
Fig 21 Open Door identified by Divers

3.9.1.2 Divers were engaged to carry out an underwater survey of the *Fluvius Tamar*. A photograph taken on the 25th January 2017 at 1740 56 seconds., identified the watertight door was located at the focsle break.

3.9.1.3 Subsequent inspection of photographs taken from the *Fluvius Tavy*, Divers photograph of the open door and the photograph taken once the vessel was salvage, confirmed the open door was the for'd cargo hold door.

- 4.7.1 The underwater survey revealed the Forward Cargo Hold Entrance Door was open at the time of the foundering, although the ship's crew in their statements indicated all doors were closed on departure from Eemshaven.
- 4.7.2 There was no indication the cargo hold door had been damaged prior to departure, which might have prevented the door from being fully dogged down.
- 4.7.2 The distortion to No. 3 hatch cover was likely to have been caused as the vessel foundered.

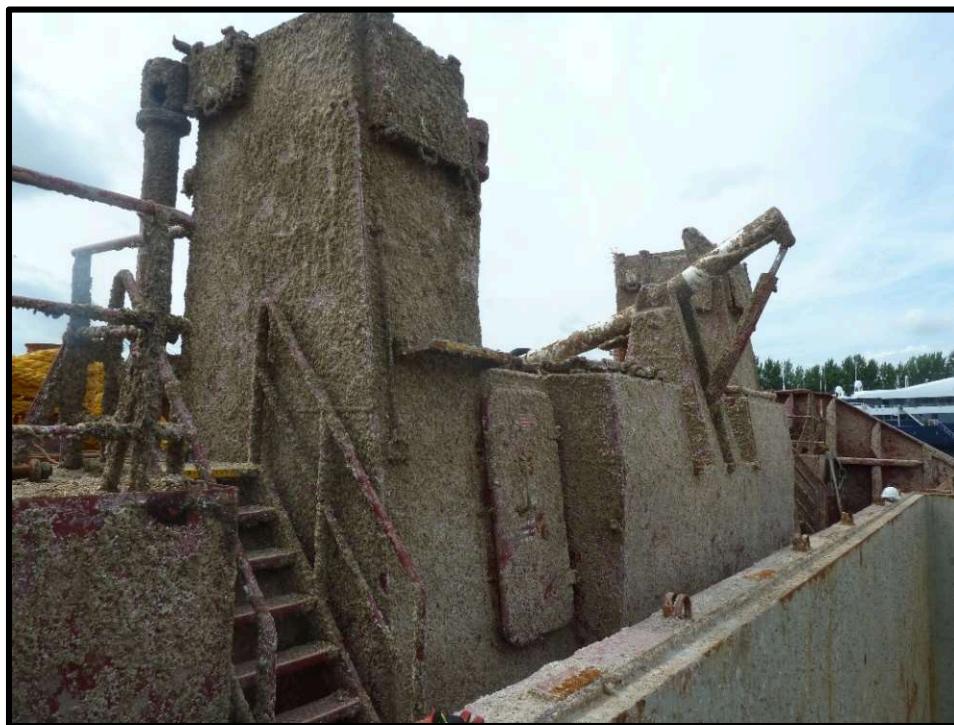
Fig 22 Cargo Hold Door – after salvage

3.1.9.4 Comparison of the doors below and the orientation of the inner closing handle and the upper dog, confirmed the Cargo Hold Door was open at the time of sinking.

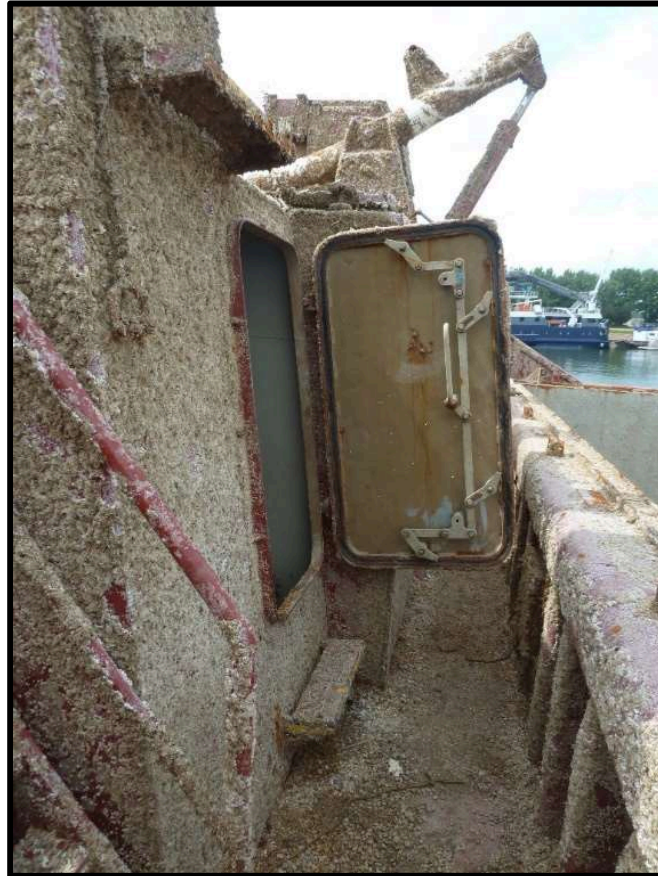
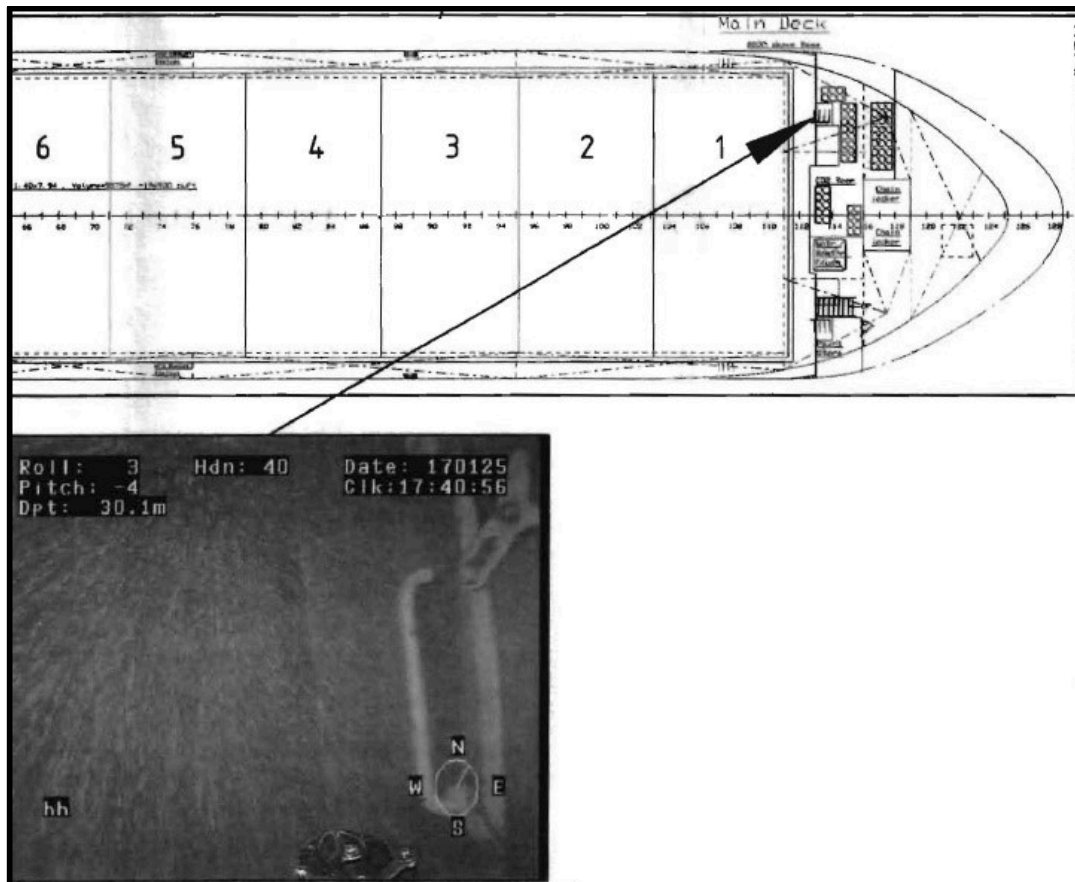
Fig 23 Cargo Hold Door

Fig 24 Location of Cargo Hold Door & underwater image

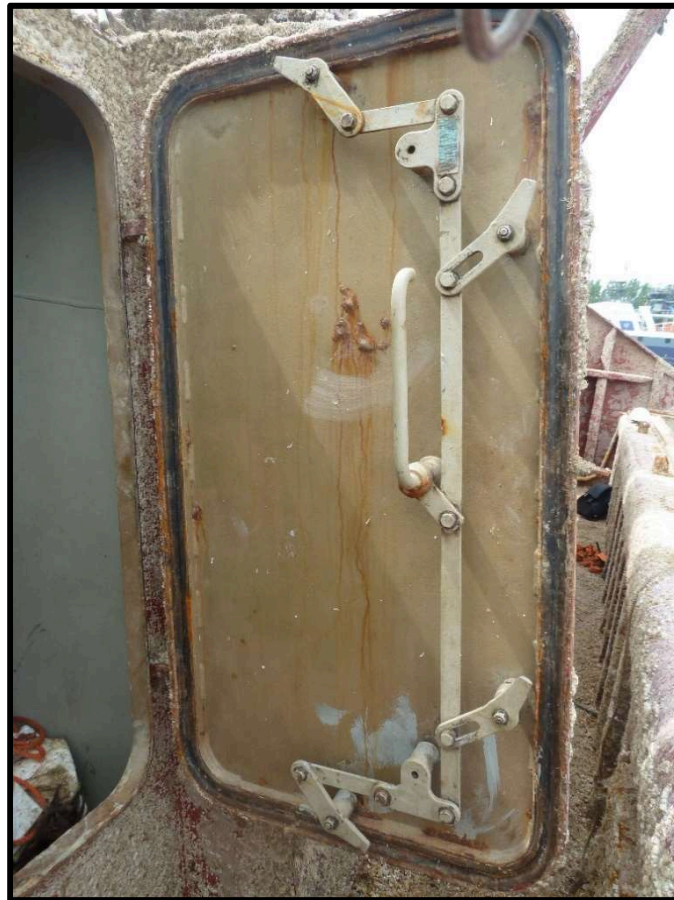
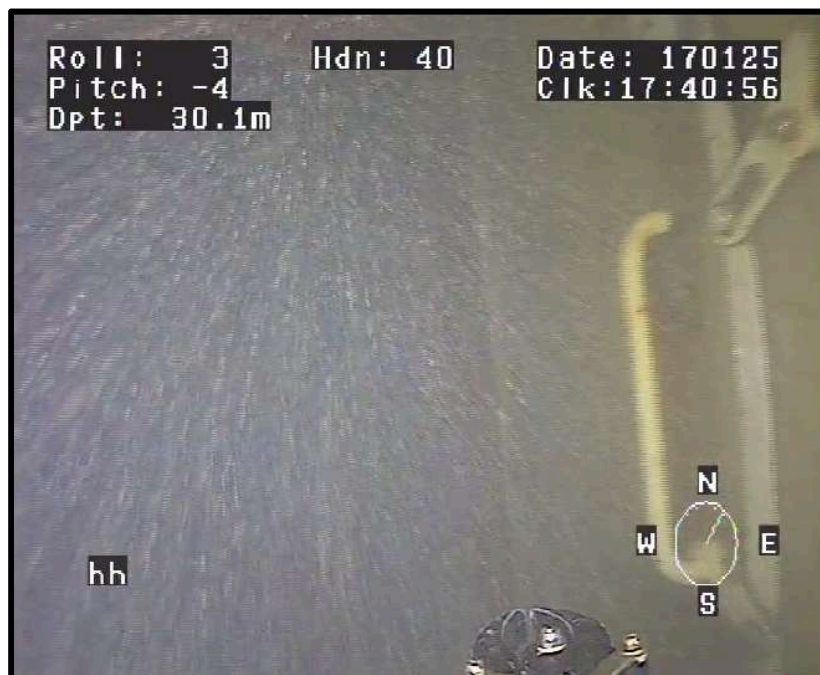
Fig 25 Cargo Hold Door

Fig 26 Cargo Hold Door - view from portside

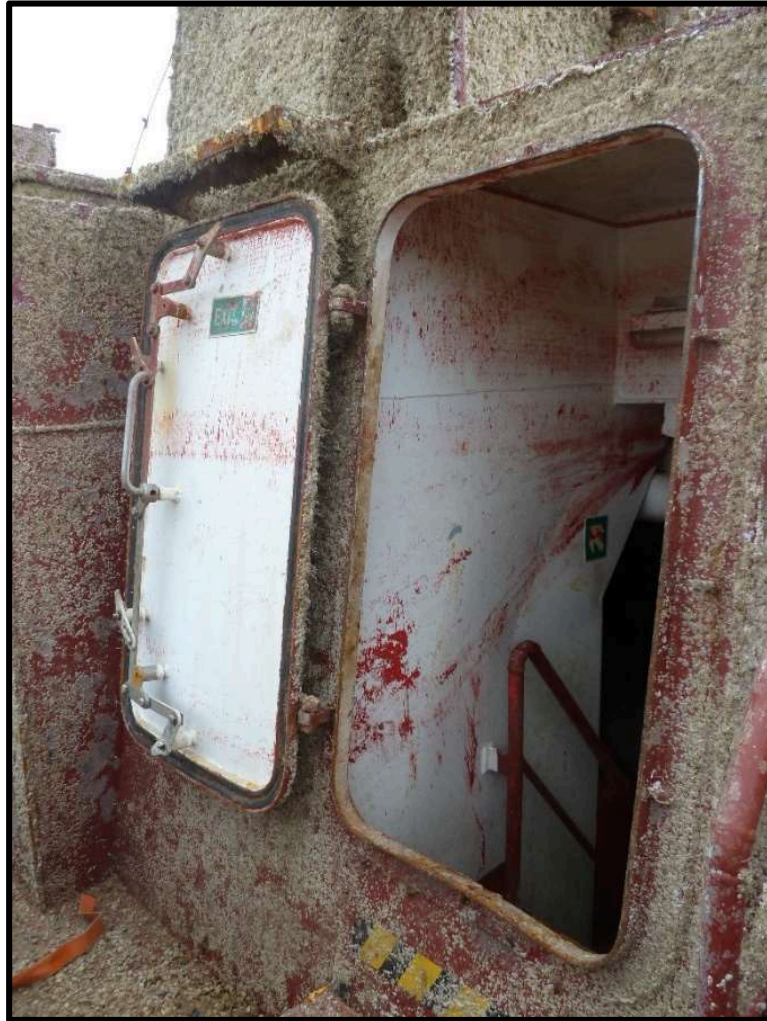
Fig 28 Focsle Door

- 3.9.2.3 Inspection of the focsle door once the ship was raised, revealed that the door seals showing signs of compression with no presence of growth along the seal.
- 3.9.2.4 Further inspection of the focsle door and door frame showed the lower part of the door frame to be set down. We are unable to explain how this damaged occurred, but believe the door was closed at the time of the sinking.

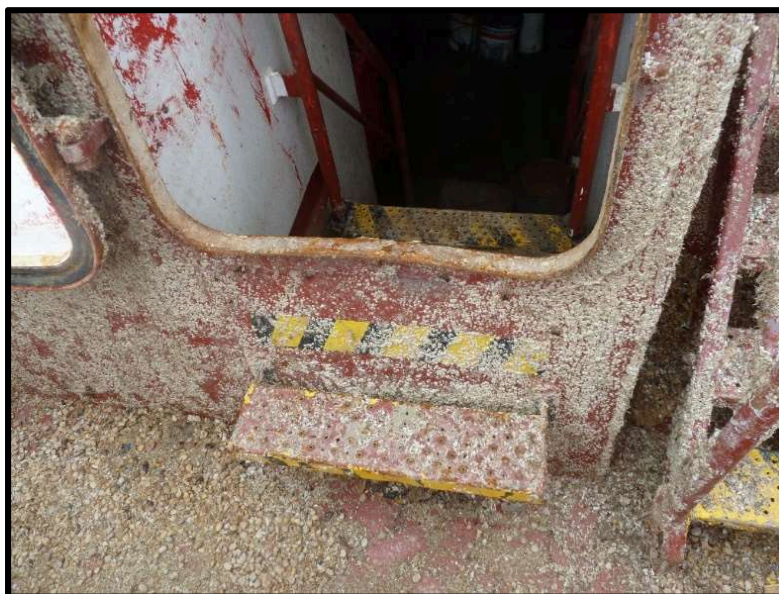
Fig 29 Focsle Door – distorted bottom of frame

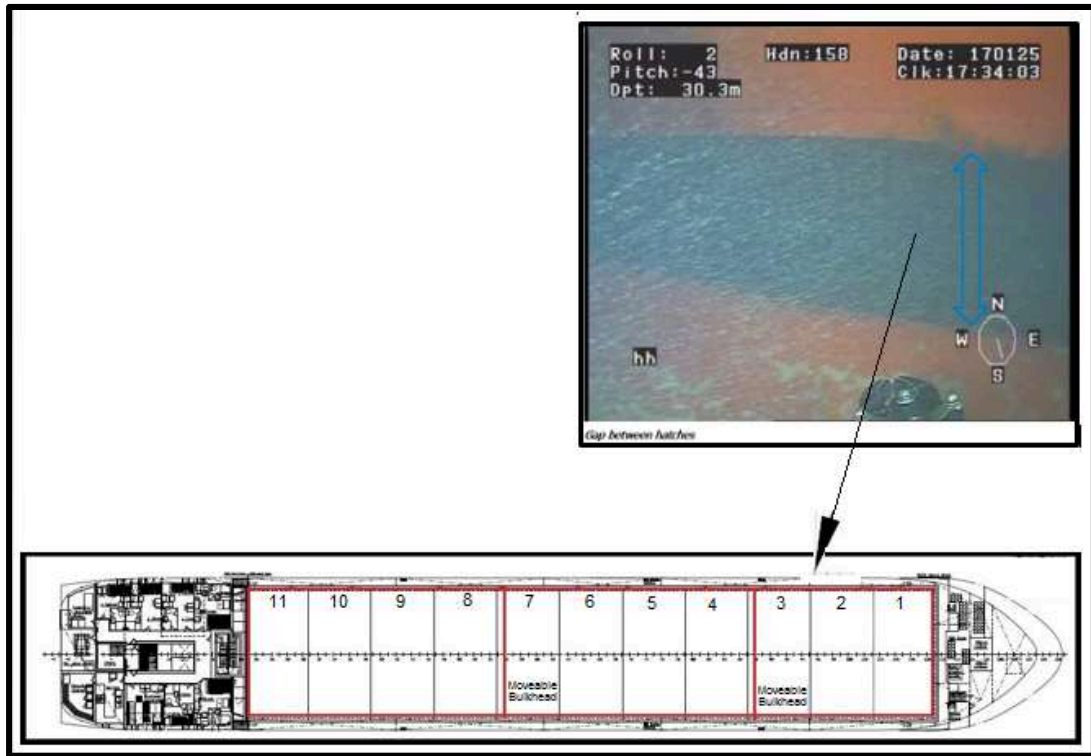
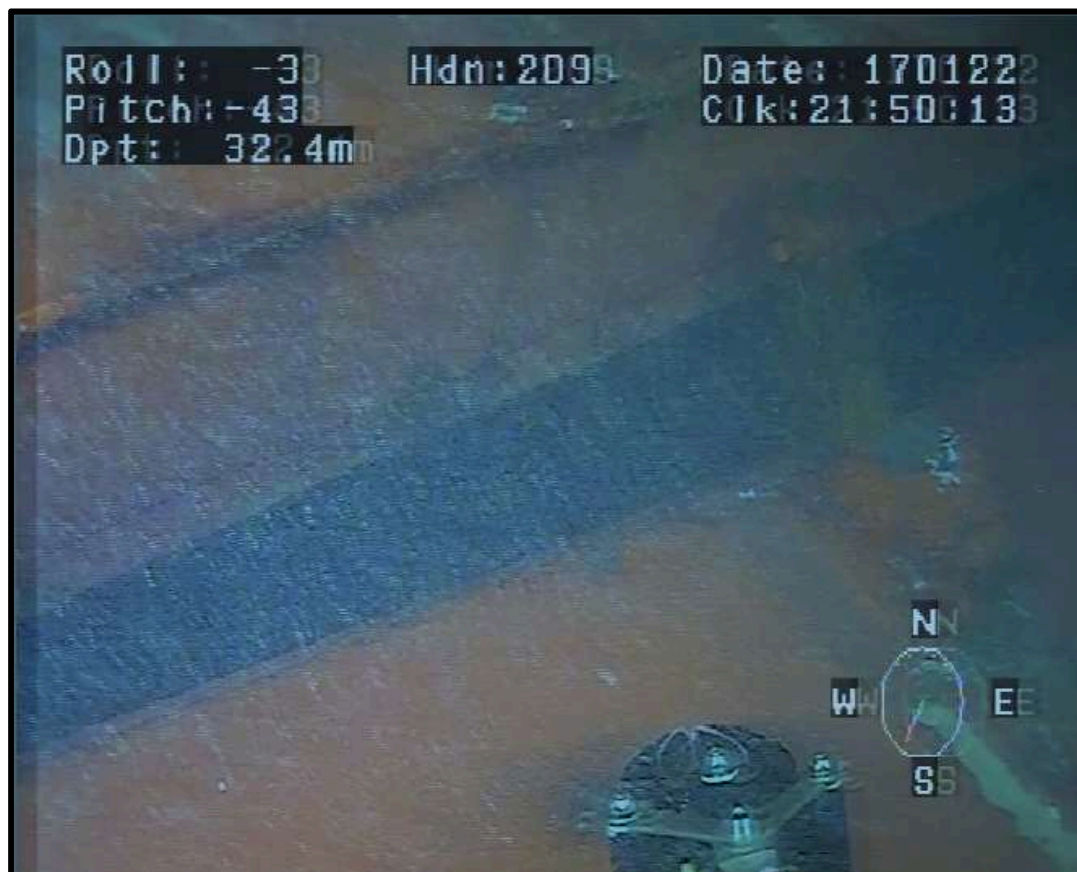
3.9.3.2 All hatch covers were found to be in place during the underwater inspection, although hatch cover No:3 was distorted upward by 60 – 80 cm in the middle. As a result, the No: 3 hatch cover was offset 10 – 20 cm to starboard. All quick acting dogs were broken, and the hatch top cleats locking the adjacent hatch covers were also broken.

3.9.3.3 This distortion to No. 3 hatch cover is likely to have occurred as the vessel sank with the hold already full of water via the open Cargo Hold Door. As the

Fig 32 Distorted No. 3 hatch cover

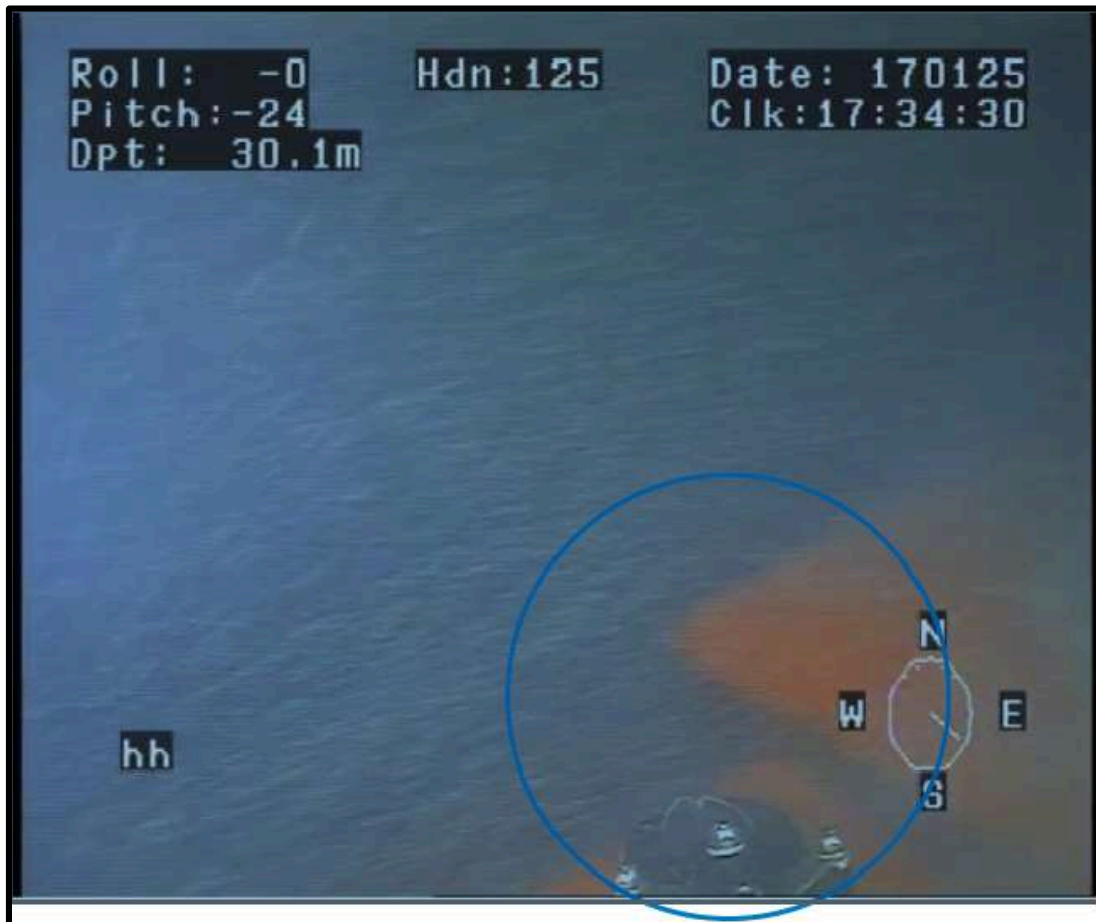
Fig 34 Offset No. 3 hatch cover

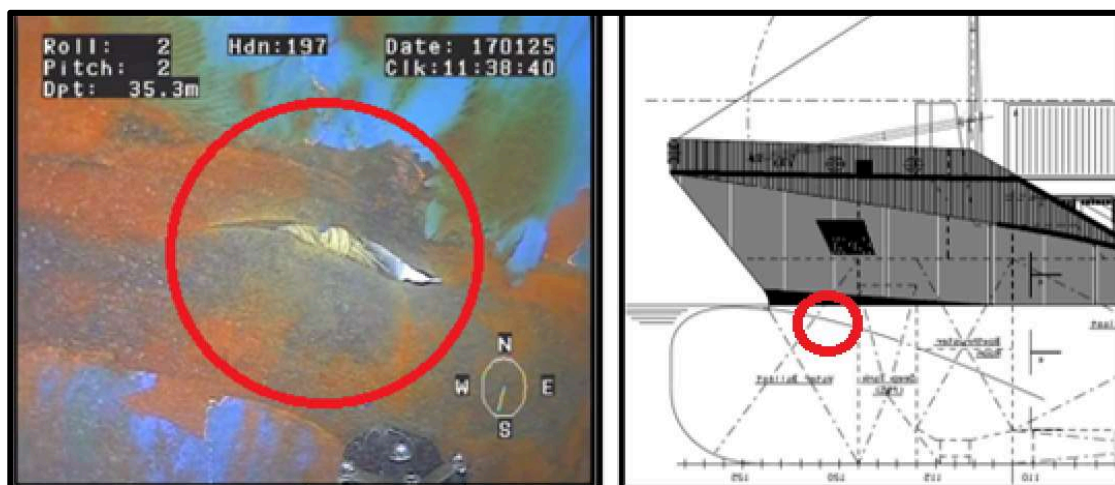
3.9.4.1 The bow section of the *Fluvius Tamar* on landing on the sea bed was pushed up. The plating on the bulb was completely deformed, dented with serious cracks, while the bulwarks on the focsle were buckled and the focsle deck severely bowed inwards.

Fig 35. Tear when vessel touched bottom

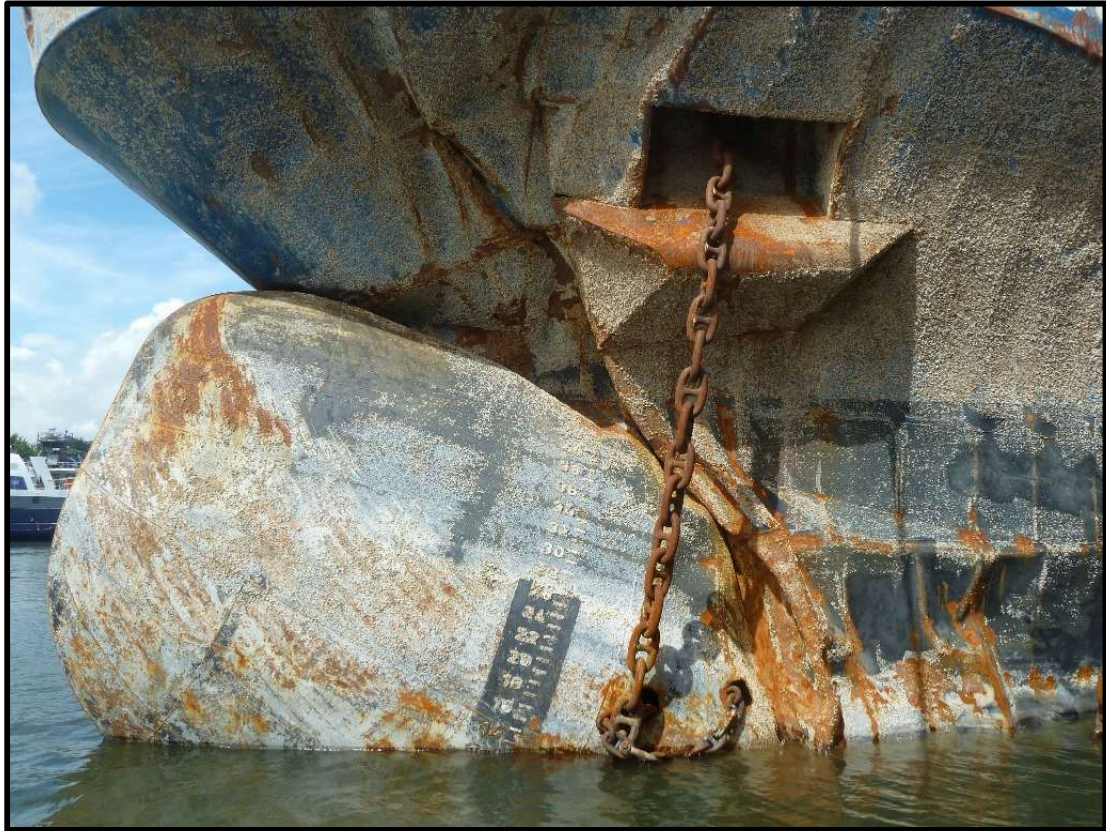
Fig 36 Damage to Bulb section

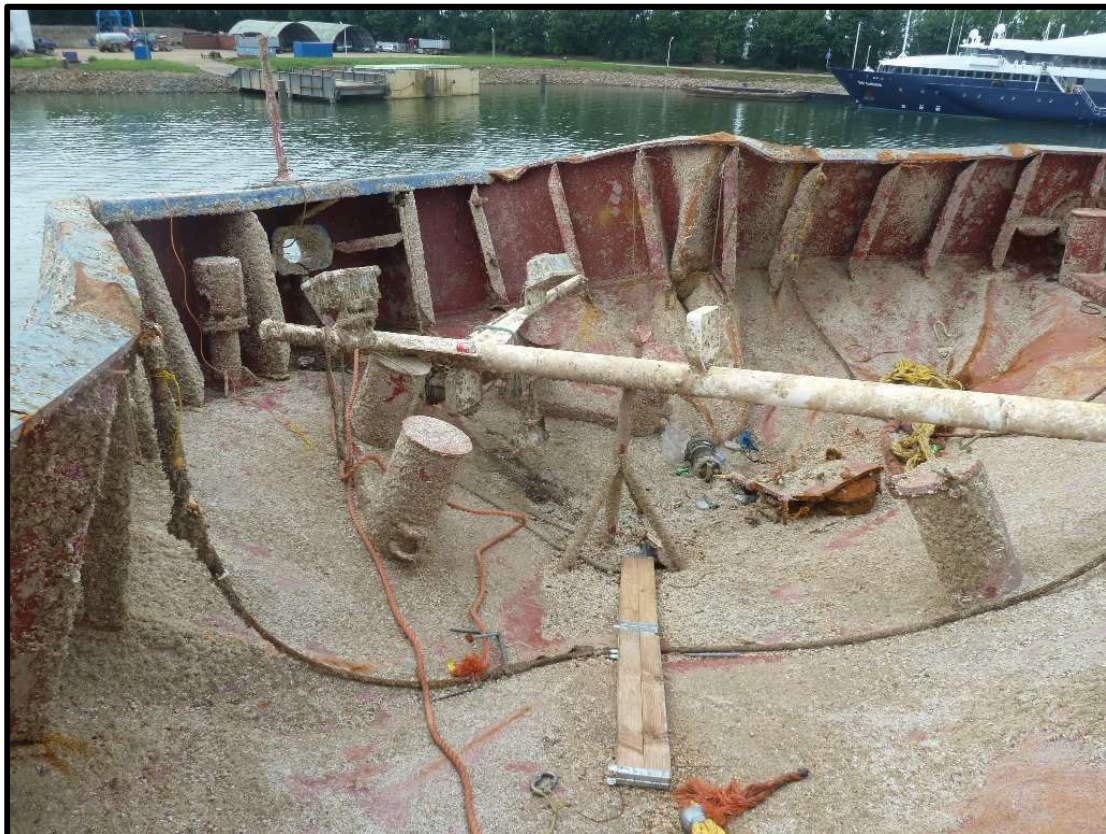
Fig 37 Damage to Focsle

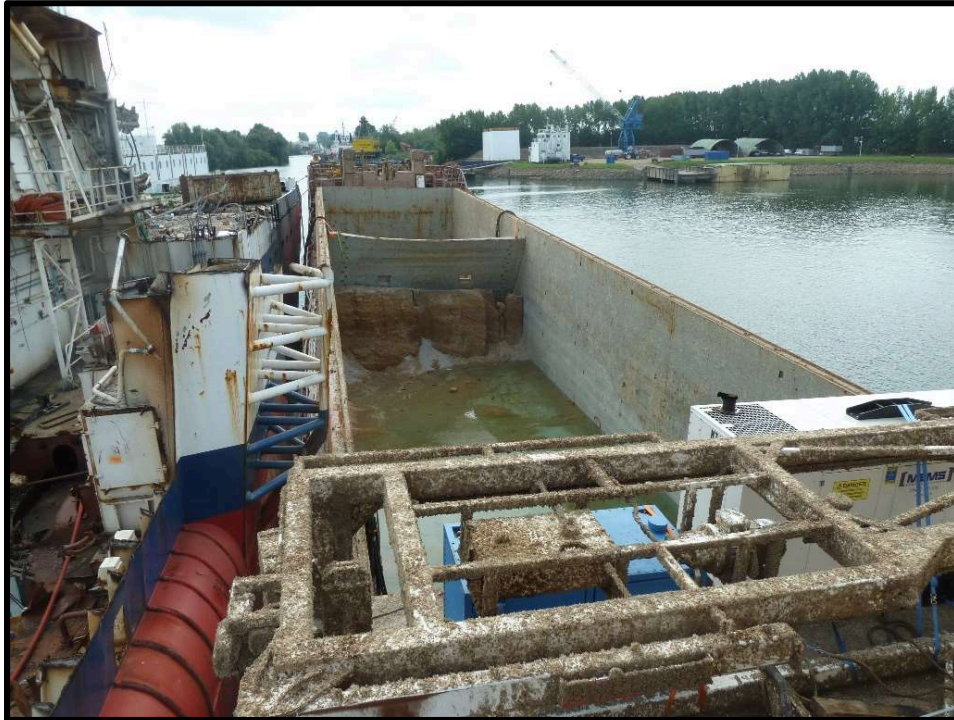
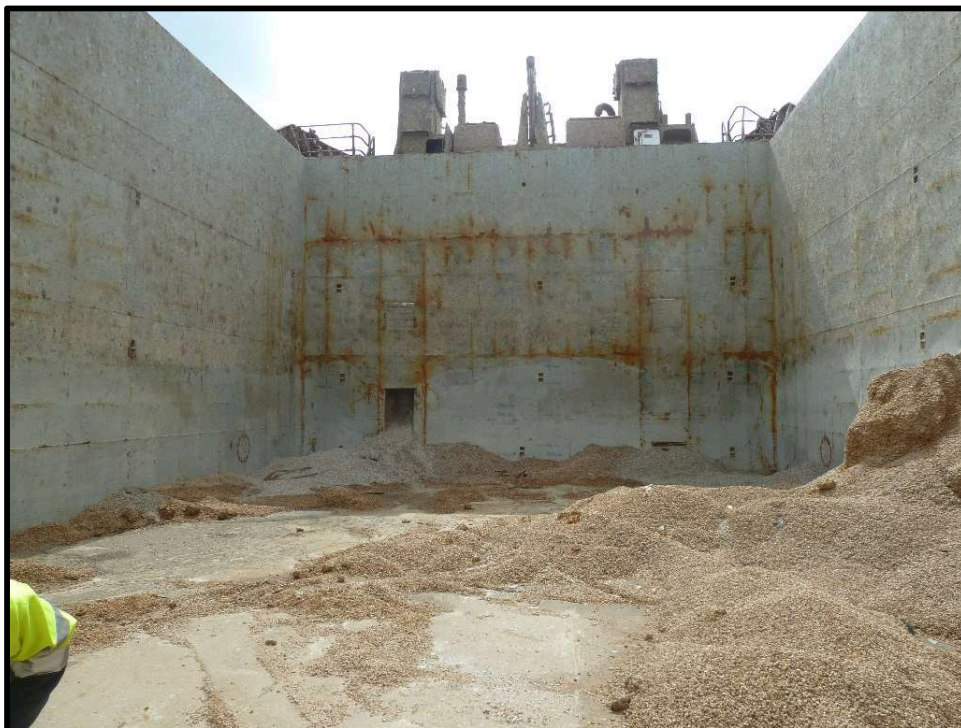
3.9.5.1 Inspection of the cargo hold after recovering the *Fluvius Tamar*, revealed the hold to be intact, with no sign of significant damage. Damage to the moveable Bulkheads occurred during the discharge of the cargo while the vessel was lying on the seabed.

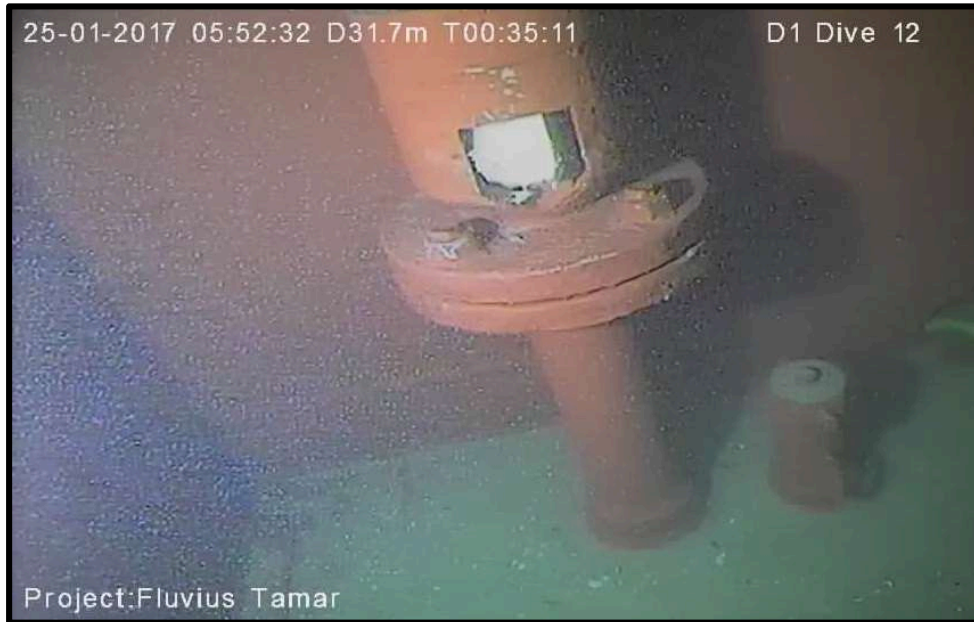
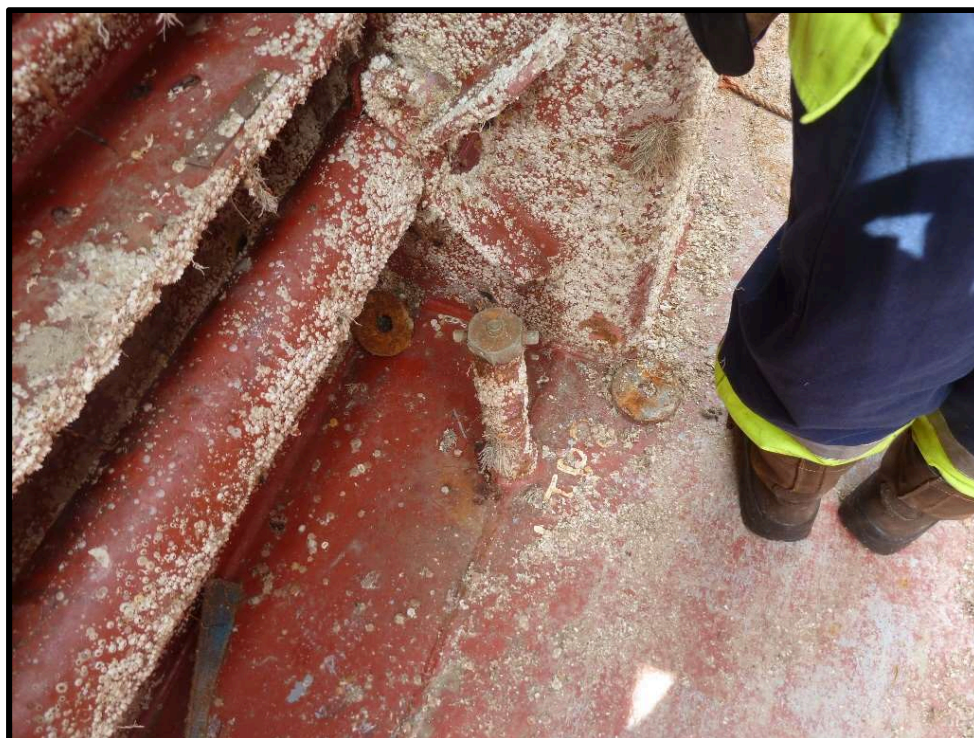
3.9.6.1 Throughout the salvage operation no evidence was viewed regarding ventilators, ballast valves or sounding pipe covers being defective or left open.
