**Report of Investigation
into the Collision between
Barbados registered
container carrier *HADIS* and
PRC registered dry cargo ship
GUANG BO YUN 328
in Hong Kong waters
on 1 September 2011**

The Hong Kong Special Administrative Region
Marine Department
Marine Accident Investigation Section

16 May 2013

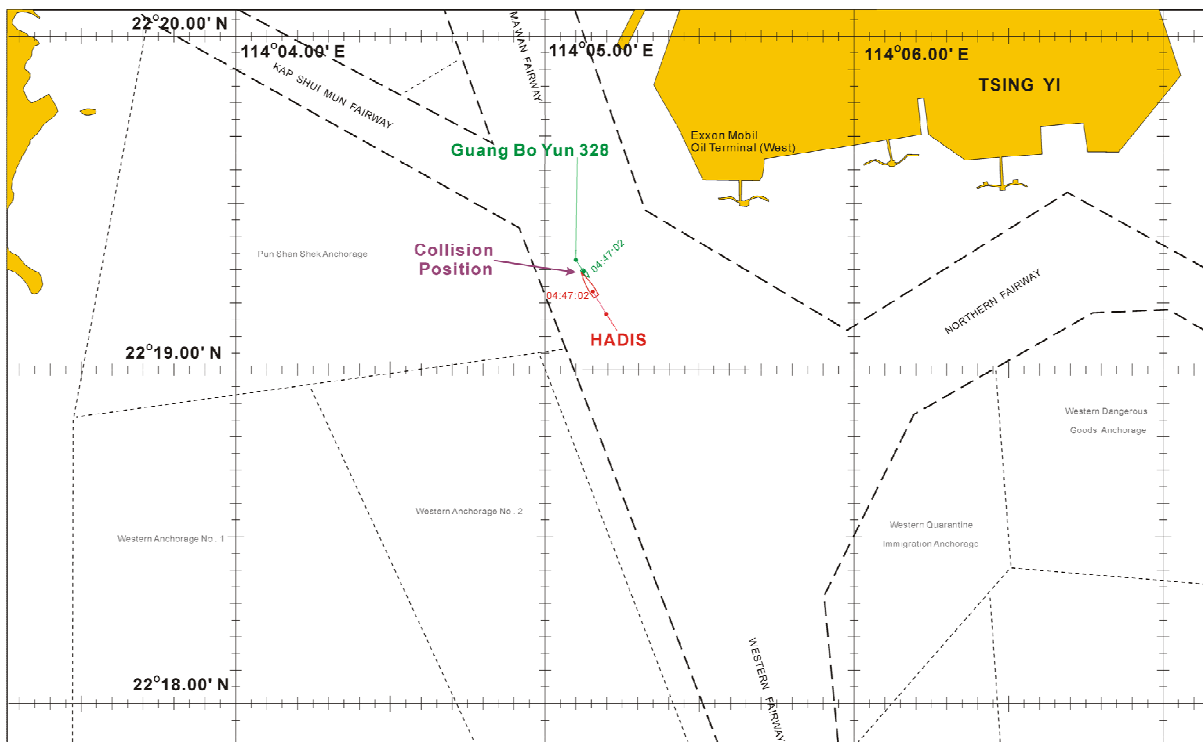
Figure 2 – Location of accident

- .1 According to the radar tracks of *HADIS* and *GUANG BO YUN 328* provided by the Vessel Traffic Centre of Hong Kong Marine Department, the collision occurred at 0447₀₂ on 1 September 2011 at Lat. 22° 19.3' N and Long. 114° 05.1' E in the fairway junction about 0.5nm to the southwest of Tsing Yi Island, Hong Kong.

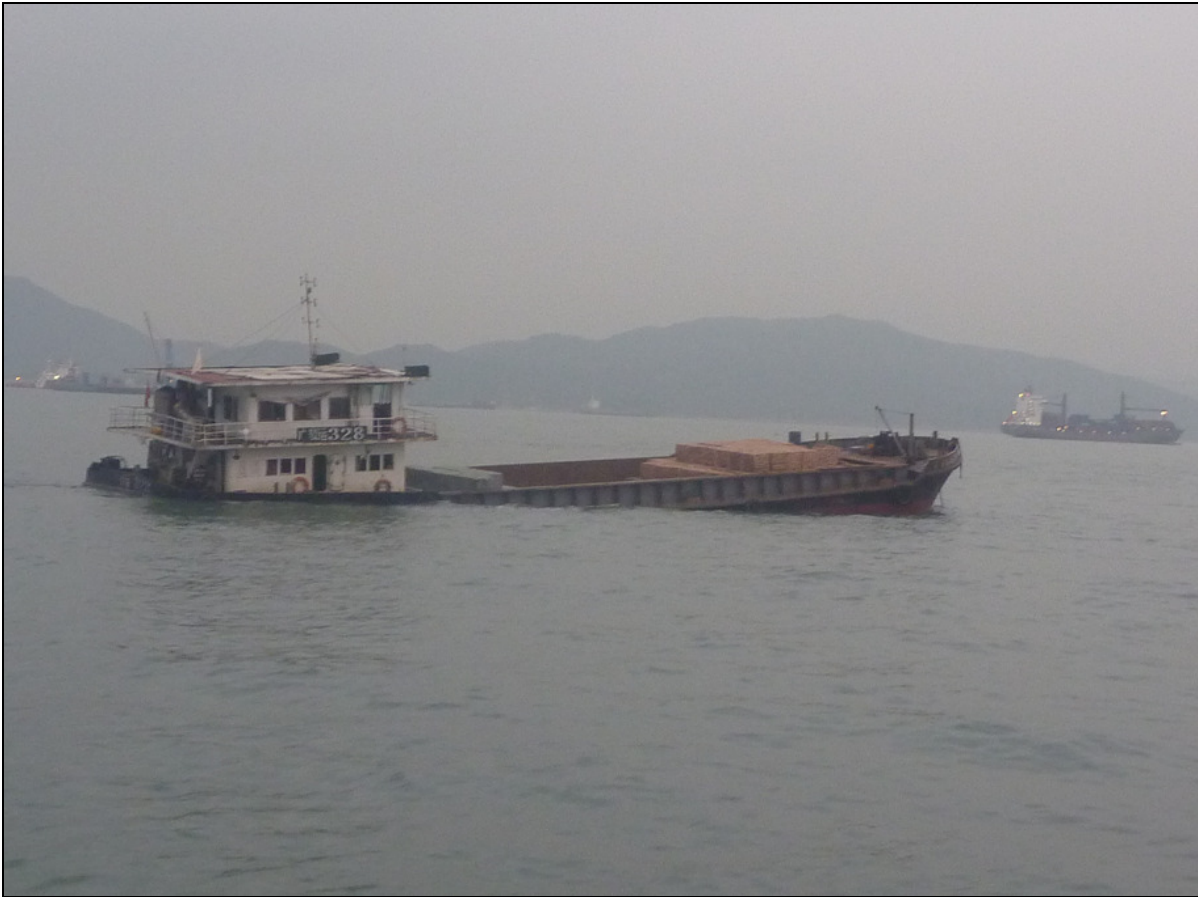
Figure 3a – *GUANG BO YUN 328* sank by the stern and slightly listed to starboard after the collision, and finally foundered in about 2 hours.

- .2 The collision damaged the starboard quarter of *GUANG BO YUN 328* and the side shell of the engine compartment of the vessel was pierced causing it to be flooded by seawater. The vessel sank by the stern with a slight list to starboard and managed to remain afloat but was drifting southward towards Western Anchorage No. 2. All six crewmembers managed to board the vessel's lifeboat and were subsequently located and rescued by a Marine Police Launch. The vessel finally foundered in the waters in the Western Anchorage No. 2 in about 2 hours at 0725 the same day. (AD/MP: There was no indication that the vessel sank further. It is noticed that the depth of water in WA2 is shallower. This may explain why 328 foundered in WA2.)

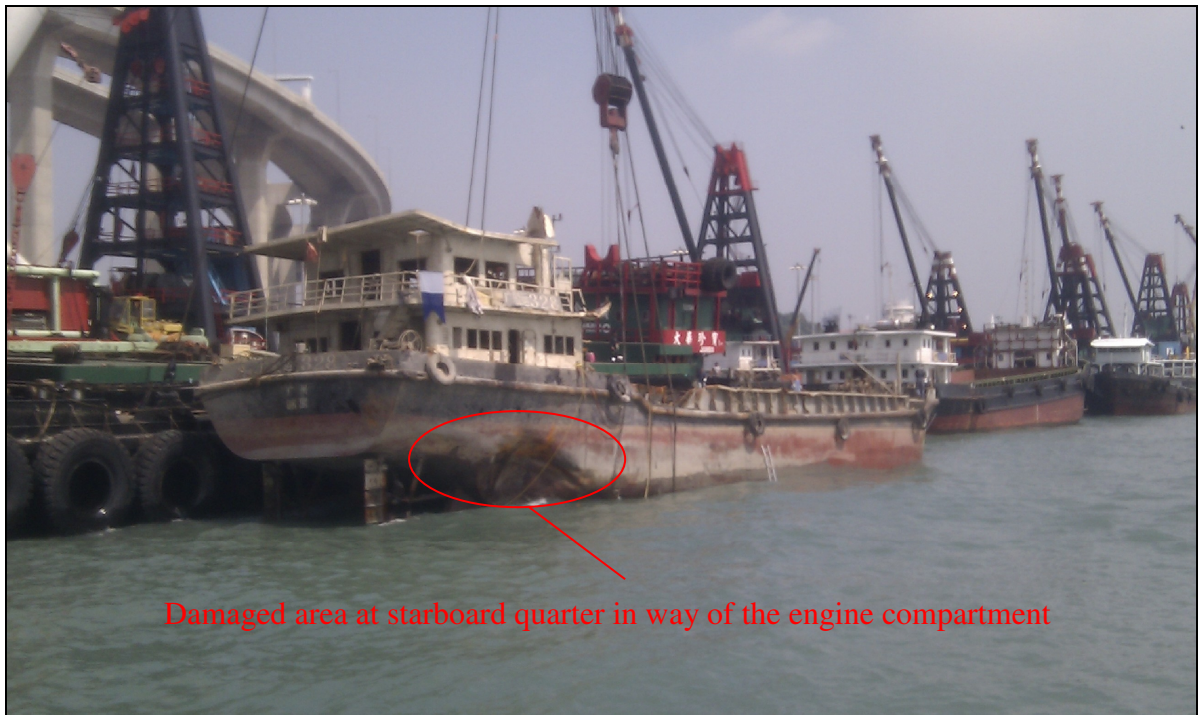
Figure 3b – *GUANG BO YUN 328* secured alongside a berth after being salvaged and temporarily repaired.

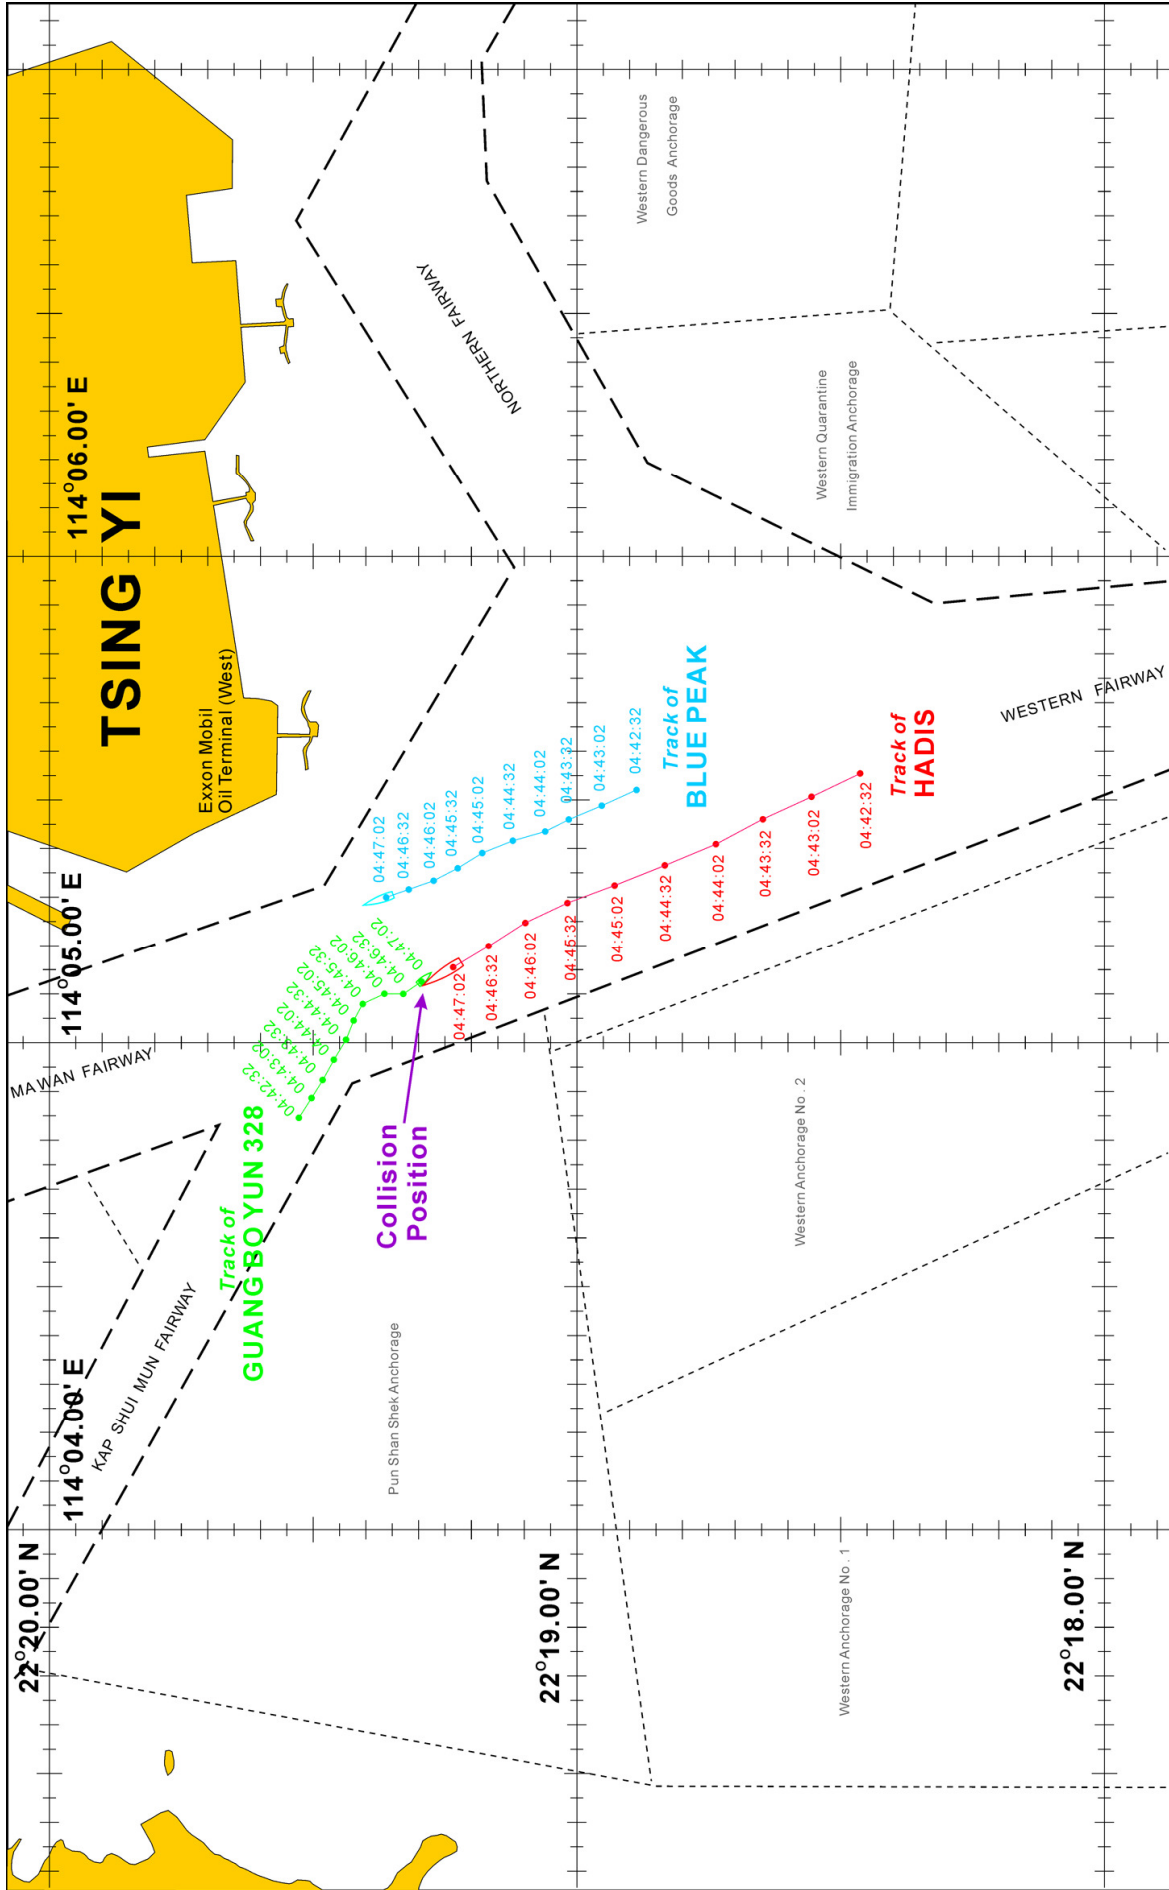
Figure 4 - Radar Plot showing the Collision Tracks of HADIS and GUAN BO YUN 328

- .5 The Pilot gave an order to alter course to port after observing that *GUANG BO YUN 328* intended to cross ahead of *HADIS* because a course alteration to starboard could take the ship too close to another vessel i.e. *BLUE PEAK* which lied to the forward of her starboard beam on an almost parallel course at a range of about 0.23nm from the vessel. He probably acted in accordance with Rule 17(c) which stated that when a stand-on vessel takes action, it may alter course to port if the circumstances permit. In normal circumstances, this is not considered to be safe manoeuvre because the give way vessel may alter course to starboard to go round the stern of the stand-on vessel at the last minute when the navigation watch-keeping officer on the give way sees that his vessel cannot pass ahead of the stand-on vessel. In this case, *HADIS* without knowing the maneuvering intention of *GUANG BO YUN 328*, the two vessels end up in a more dangerous situation when the stand-on vessel alters course to port and ends up in the path of the give-way vessel. In this connection, *HADIS* is not complying with Rule 17(c) of the COLREGS. Probably the best option for *HADIS* was to take early avoiding action by reducing the ship's engine speed to a stop and/or even going astern. Had this action been taken, *GUANG BO YUN 328* would probably pass clear of *HADIS*. According to the VTC radar plot in *Figure 4* and *HADIS*'s VDR record, when the Pilot gave order to reduce the engine speed from full ahead to half ahead at 0444₀₇, *GUANG BO YUN 328* was on a bearing of 330° and at a range of 0.76nm (about 1405m) from *HADIS*. At 0445₅₃, when the order to stop engine was given, *GUANG BO YUN 328* was on a bearing of 333° and at a range of only 0.27nm (about 491m) from *HADIS* which was still making a speed of 11 knots. The order of "stop engine" given at 0445₅₃ was only 1 minute 46 seconds after the first order to reduce the engine speed was given at 0444₀₇. It is considered that the action to slow down or stop the vessel should be taken earlier in order to avoid the close-quarters situation and/or the collision.

- .3 Referring to the target information above and the VTC radar plot of *GUANG BO YUN 328* in Figure 4, the vessel proceeded along the Kap Shui Mun Fairway with a course of 127°T and a speed of 5.5 knots at 0442₀₅. Between 0442₀₅ and 0445₂₀, the vessel altered course to port slowly from 127°T to 111°T. At 0445₂₀ the vessel altered course to starboard from 111°T to 179°T at 0446₂₆. The vessel then altered course to port from 179°T at 0446₂₆ to 150°T at 0447₀₂ when the vessel's starboard quarter was struck by *HADIS*. The speed of the vessel was between 4.5 and 5 knots throughout the passage.

- .4 Rule 15 of the COLREGS stipulates that in a crossing situation, the give-way vessel shall avoid crossing ahead of the other vessel if the circumstances permit. Rule 16 further requires that the give-way vessel shall take early and substantial action to keep well clear. In this incident, *GUANG BO YUN 328* being the give-way vessel failed to comply with the requirement to take early and substantial action to keep clear of *HADIS*.
