## Engine room flooding leading to abandonment and grounding of MV BLUE LAGOON, Lanyu Island, Taiwan

**Blue Lagoon (formerly Sterling Tora)**

## SUMMARY

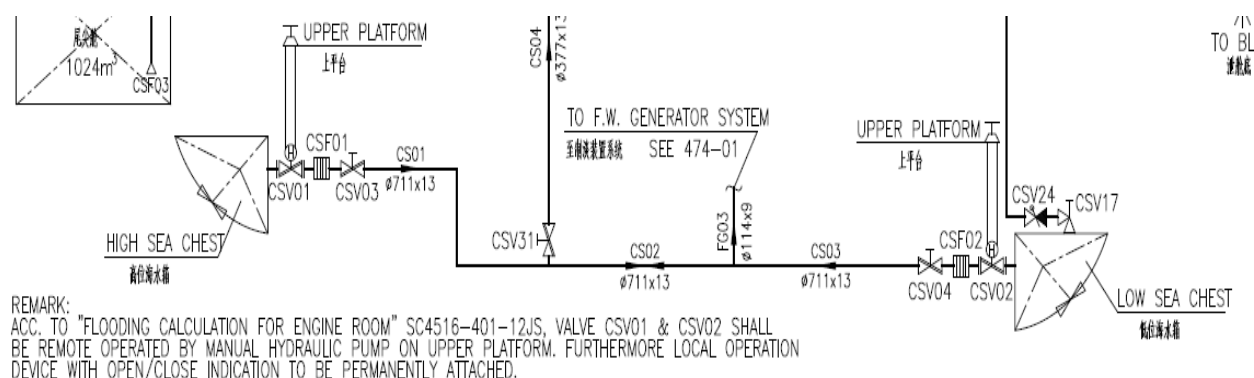
**Figure 2 – Diagram showing the sea chests and associated valves.**

With the water level in the engine room continuing to rise, the C/E, 2/E, 4/E and the motorman remained on the engine room's lower platform. Between them, they attempted to close the sea chest isolation valves manually (CV01 and CV03 on the high sea chest, and CV02 and CV04 on the low sea chest (**Figure 2**)), or to check that they were closed.

The engineers' accounts of who closed or checked the individual valves were inconsistent and contradictory. Consequently, the precise details of the action taken, regarding who did what, and how the positions of the valves were checked is uncertain. Some accounts highlighted that the situation was extremely stressful and that the valve hand wheels were difficult to turn and required two persons. The C/E's understanding was that all four of the isolation valves were closed, but the pressure at which seawater continued to spray from the fracture in the main seawater pipe remained unchanged.

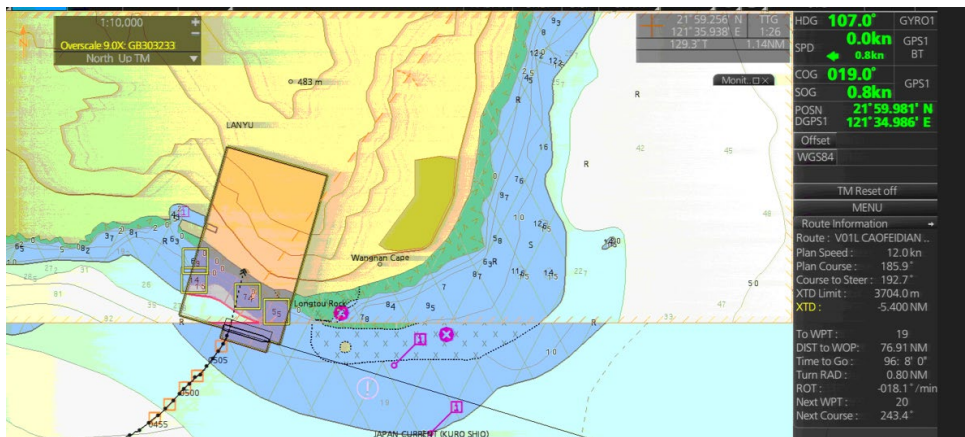
**Figure 6 – ECDIS extract at 1306**

At about 1300, the port anchor was also let go as Blue Lagoon crossed the 50m depth contour, but the ship grounded several minutes later (**Figure 6**). The captain was now concerned about the dangerous deck conditions and the potential breaking up of the ship. Keelung Radio advised the crew to stay on deck wearing lifejackets and be prepared to swim ashore if necessary.

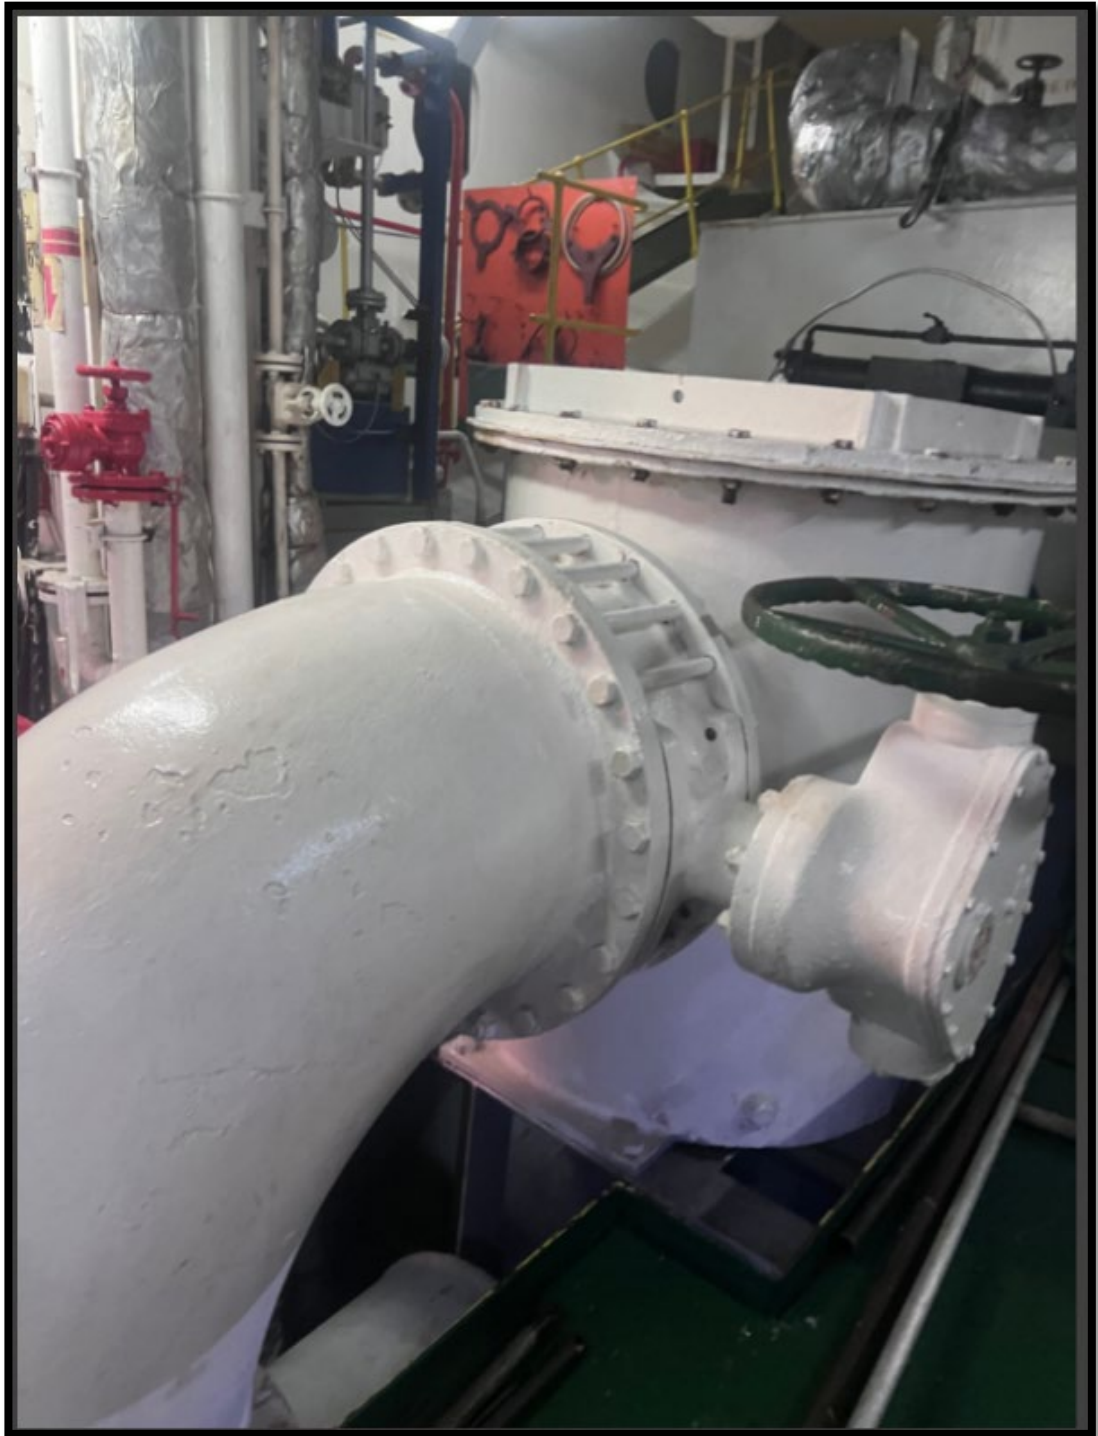
**Figure 10 – The main seawater pipe from a sea chest filter**

Seawater was used as the medium to cool Blue Lagoon's main engine and auxiliary machinery. The seawater was drawn from two sea chests (**Figure 10**). The 'high' sea chest on the ship's port side and the 'low' sea chest was on the ship's starboard side.

The source of the flooding in Blue Lagoon's engine room was a fracture in the main seawater pipe connecting the high and the low sea chests. Given the ship's draught, the seawater pipe would have been pressurised to about 2.2 bar, and any fracture would potentially have generated significant seawater ingress. Assuming a discharge coefficient of 0.6, and the pipe being completely open, the resulting ingress would be approximately 218 tonnes per minute. However, the fracture in Blue Lagoon's seawater pipe was reported to have extended approximately one quarter of the pipe's circumference. It would therefore have been approximately 56cm in length, and although the discharge coefficient would be much lower, it is impossible to estimate, particularly as it has not been possible to access and inspect the fracture in detail.

Likewise, because it has not been possible to conduct a metallurgical analysis of the fractured weld, its causation remains speculative. The split in the seawater pipe was reported to be at the site of a weld on a flange connection, and flange connections are potentially weaker points in a seawater pipeline's structure. As such, they are susceptible to vibration and stresses that result from a ship's motion. In this case, at the time of the fracture to Blue Lagoon's seawater pipe, the ship was experiencing gale force winds, 6m to 9m high waves and was pitching, and rolling up to 20°. In such conditions, the torsional, racking, and sheer stresses on the ship might have been sufficient to cause the weld on the seawater pipe flange to fracture.
