**MARINE INVESTIGATION REPORT  
M10F0003**

**KNOCKDOWN AND CAPSIZING**

**SAIL TRAINING YACHT *CONCORDIA*  
300 MILES SSE OFF RIO DE JANEIRO, BRAZIL  
17 FEBRUARY 2010**

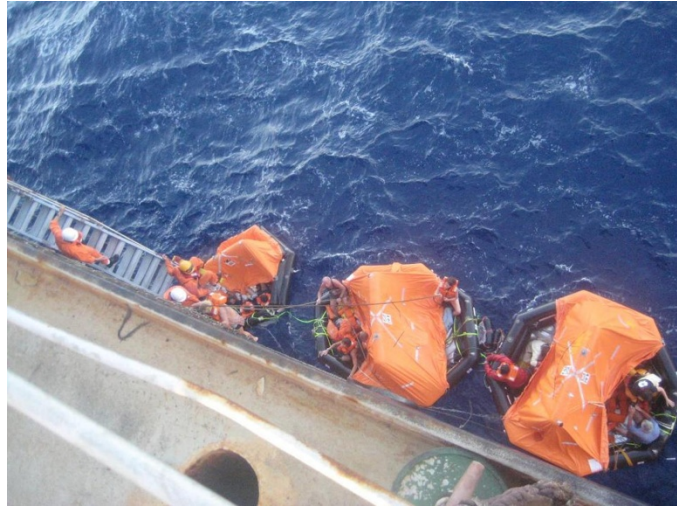
**Photo 2.** Liferafts alongside *Hokuetsu Delight*

One of the 4 rafts was retrieved from the water. This raft and its associated equipment were not available for examination during the investigation.

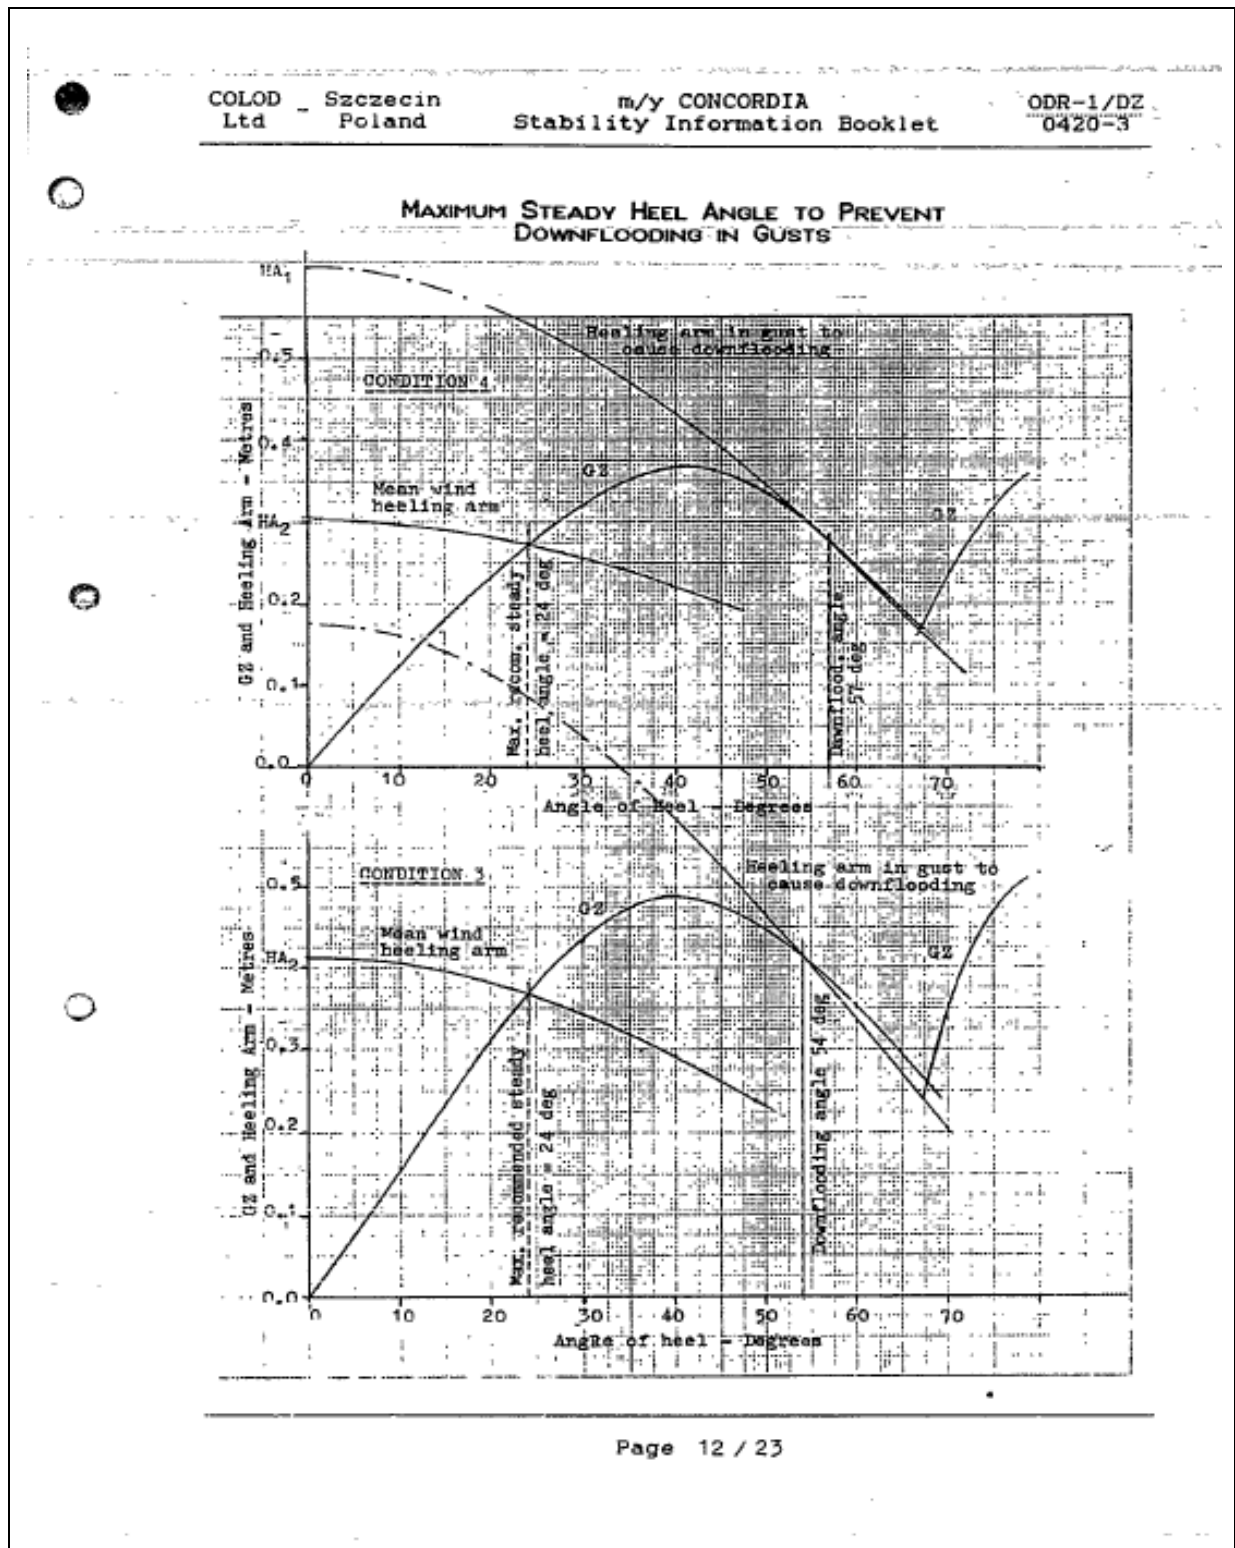
CURVES OF MAXIMUM STEADY HEEL ANGLE TO PREVENT DOWNFLOODING IN GUSTS AND SQUALLS

Curves of maximum steady heel angle indicate the range of mean or steady heel angles beyond which the vessel will suffer downflooding in the event of a squall. Operation of the vessel in cyclonic conditions particularly in the hours of darkness, where severe squalls are imminent requires the recommended maximum steady heel angle to be reduced depending on the mean apparent wind speed in accordance with the curves presented above.

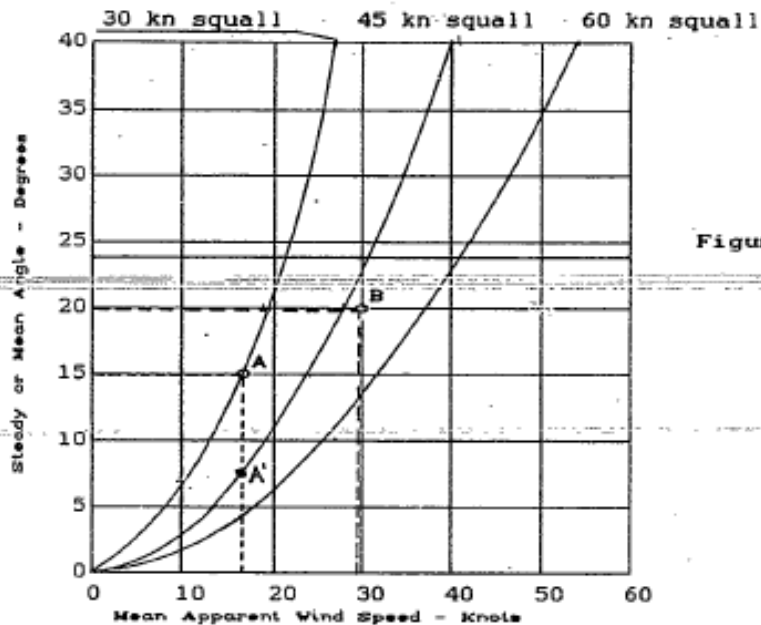
Figure 1

*Example A* The yacht is reaching, with a steady apparent wind speed of 16 knots. The mean heel angle is 15 degrees. Forecasts and visible cumulo-nimbus clouds suggest squalls may be imminent. By plotting the heel angle and wind speed (point A in Figure 1) the indication is that the vessel will be in danger of heeling to the downflooding angle in squalls of 30 knots. In order to increase safety from downflooding, say, to withstand squalls of up to 45 knots, sails should be handed or reefed to reduce the mean heel angle to 7 degrees (point A' in Figure 1) or less.

*Example B* The yacht is beating in gusty conditions with a mean apparent wind speed of 30 knots. The mean heel angle is 20 degrees. No squalls are expected. The heel angle is significantly less than 24 degrees, the maximum recommended steady heel angle, and there is therefore a good safety margin against downflooding in a strong gust. Plotting these values of wind speed and heel angle (point B in Figure 1) also indicates that the vessel would not be vulnerable to downflooding in a squall unless it resulted in a wind speed in excess of the about 50 knots. There is thus no need to reduce sail area on the grounds of stability.

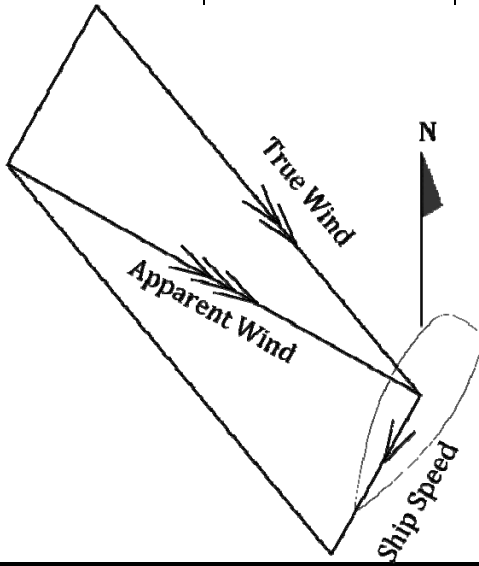
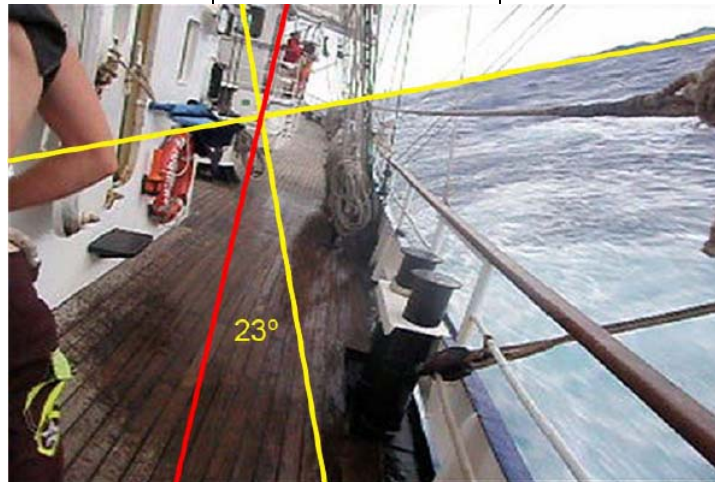
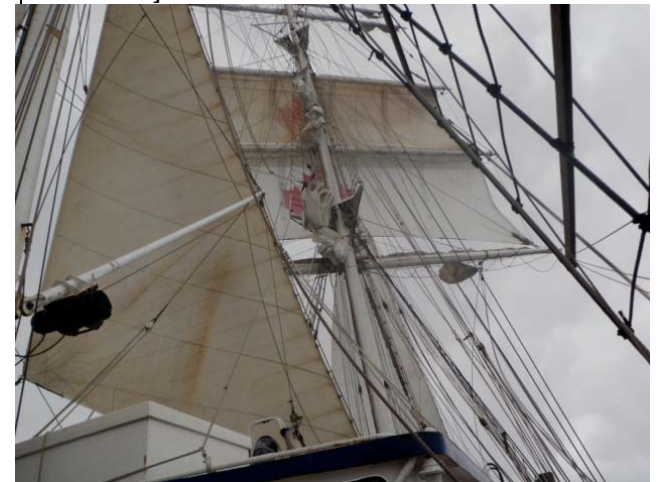
| Time Period (Approx) | Ship Speed /Heading | True Wind | Apparent Wind | Heel | Notes |
|---|---|--|---|--|--|
| <p>1420</p> <p>2 to 3 minutes - Student takes video (57 sec) showing conditions on deck and some still photos</p> | <p>Approximation: 9 knots at 210°</p> | <p>Approximation: 25 knots at 320°</p> | <p>Investigation Info: 23 knots</p> <p>Derived Using Approximations for Ship and True Wind Info: 23.5 knots at 88.9°</p> <p>* See notes</p> | <p>Investigation Info: 23° min</p> <p>Calculated range of apparent wind speed for this heel is 20 to 28 knots</p> <p>* See notes</p> | <ul style="list-style-type: none"> <li>• Analysis of video footage determined that the minimum angle of inclination of the vessel which could be discerned from the video was 23°. [See photo, below]</li> <li>• Video shows inner jib with leading edge full but trailing edge flapping; likely due to blanketing effect of forestaysail. Main staysail and main also appear full, indicating a likely apparent wind angle at least at the beam or aft of that</li> <li>• Square sails full, indicating likely apparent wind angle at least at the beam or aft of that [see photo below]</li> </ul> |
