Barbados maritime ship registry

M.V. Fluvius Tamar
IMO Number 9501708

**Report of the investigation into the Loss of the
Fluvius Tamar, while on passage from
Eemshaven to Pasajes.**

Issue by: 31st August 2017

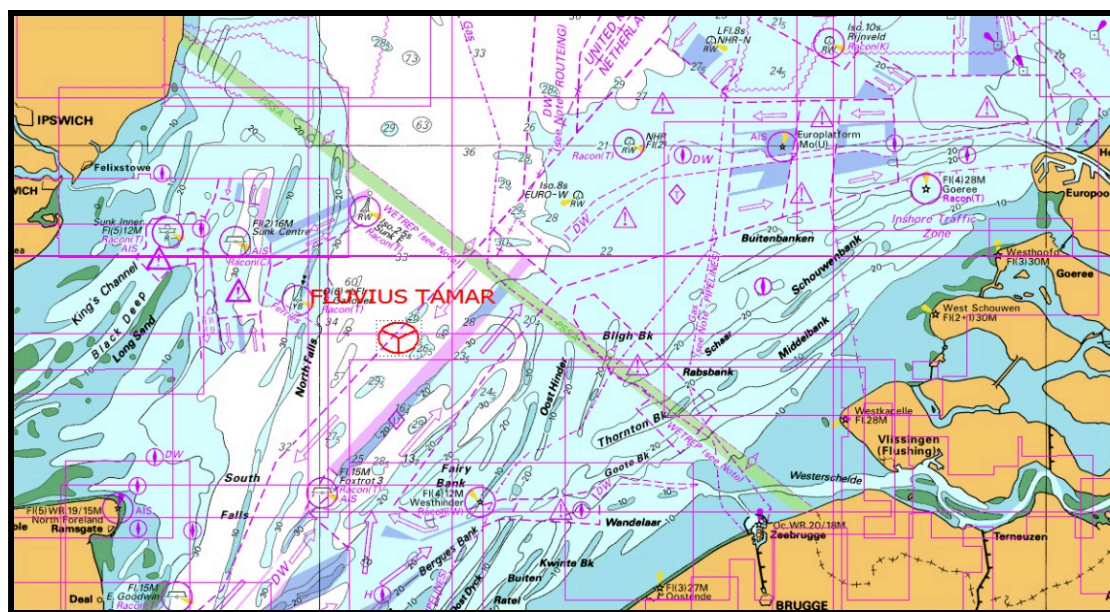
Fig. 15 Location of sinking

- 3.6.11 The last AIS transmission from the *Fluvius Tamar* was 14th January 2017, 0007utc, (0107 ships time).

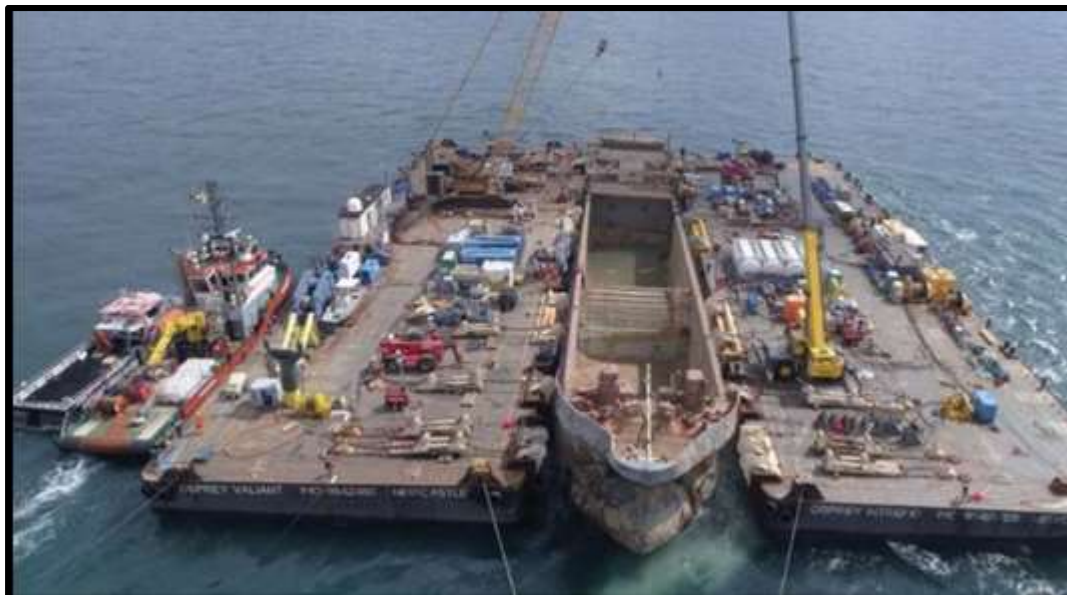
Fig 17 Fluvius Tamar (Ardent Salvage)

- 3.8.4 A full underwater survey was carried out by a specialist team towards the end of January 2017 in order that a Salvage / Removal Plan be developed to the satisfaction of the SOSREP.
- 3.8.5 This Salvage / Removal Plan was actioned, with the removal of all oils on board and discharge of the bulk cargo to barges before recovering the *Fluvius Tamar*.

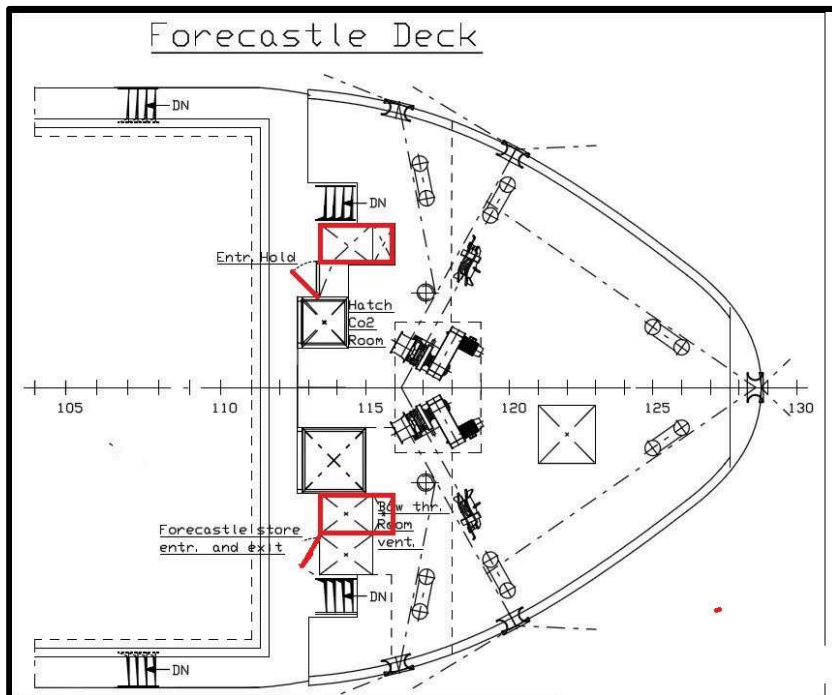
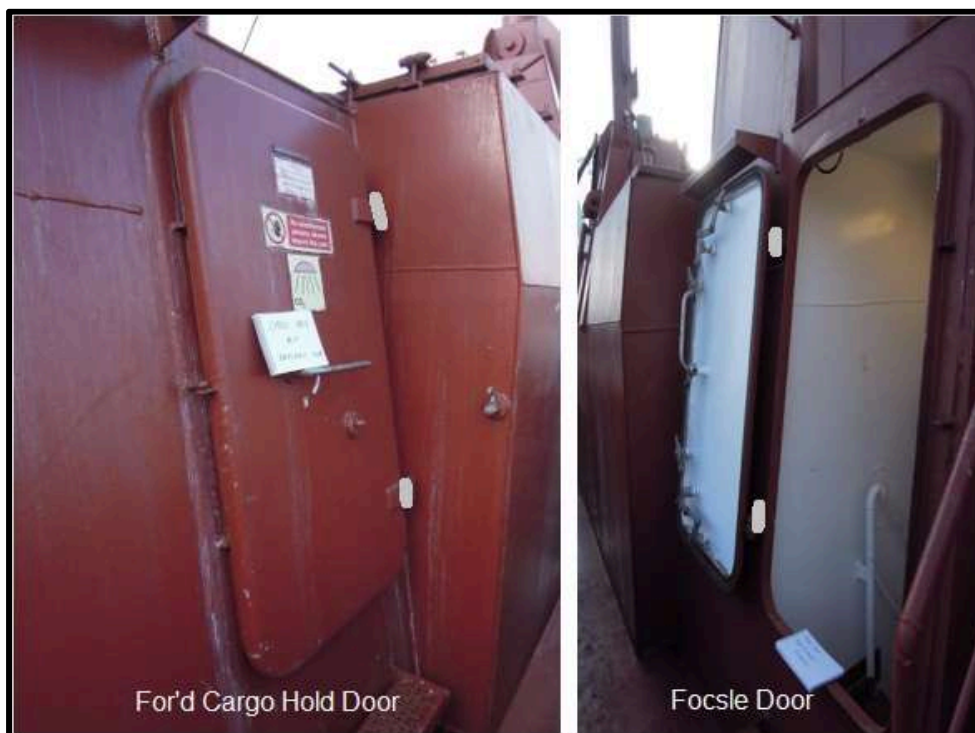
Fig 19 locations of Cargo Hold & Focsle Doors

- 4.7.1 The underwater survey revealed the Forward Cargo Hold Entrance Door was open at the time of the foundering, although the ship's crew in their statements indicated all doors were closed on departure from Eemshaven.
- 4.7.2 There was no indication the cargo hold door had been damaged prior to departure, which might have prevented the door from being fully dogged down.
- 4.7.2 The distortion to No. 3 hatch cover was likely to have been caused as the vessel foundered.

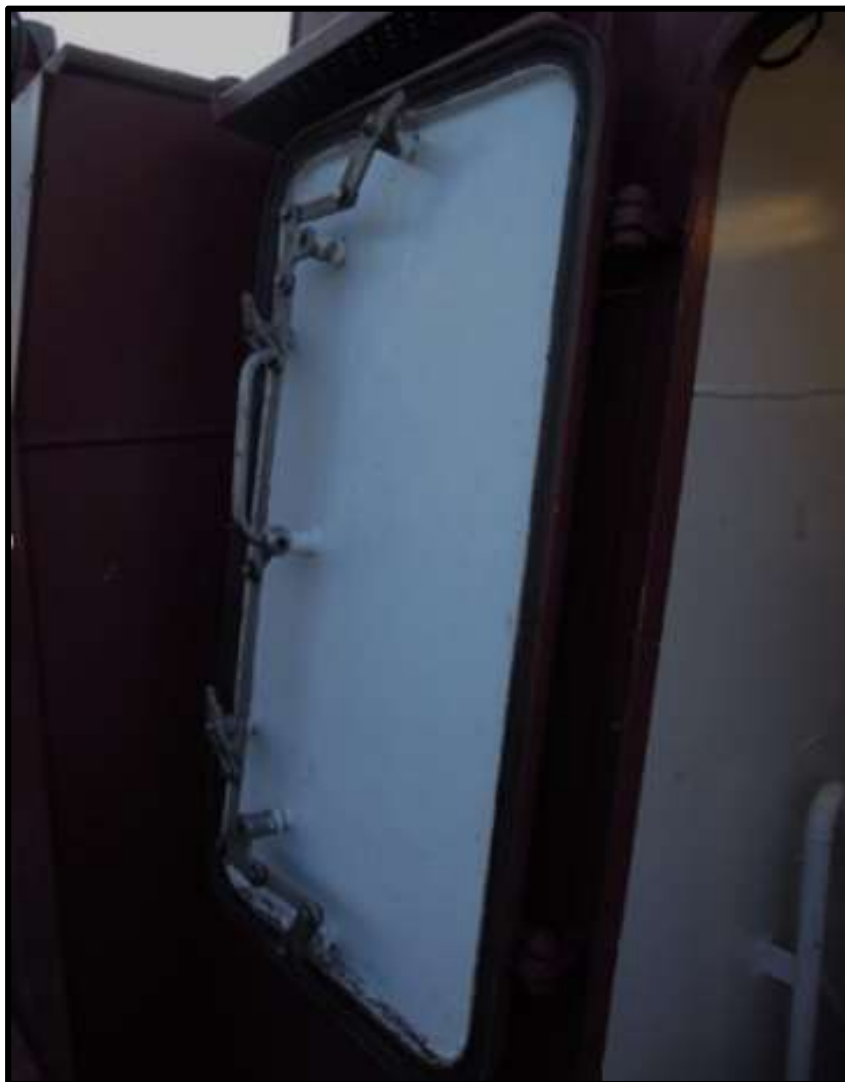
Fig 27 Focsle Door

- 3.9.2.3 Inspection of the focsle door once the ship was raised, revealed that the door seals showing signs of compression with no presence of growth along the seal.
- 3.9.2.4 Further inspection of the focsle door and door frame showed the lower part of the door frame to be set down. We are unable to explain how this damaged occurred, but believe the door was closed at the time of the sinking.

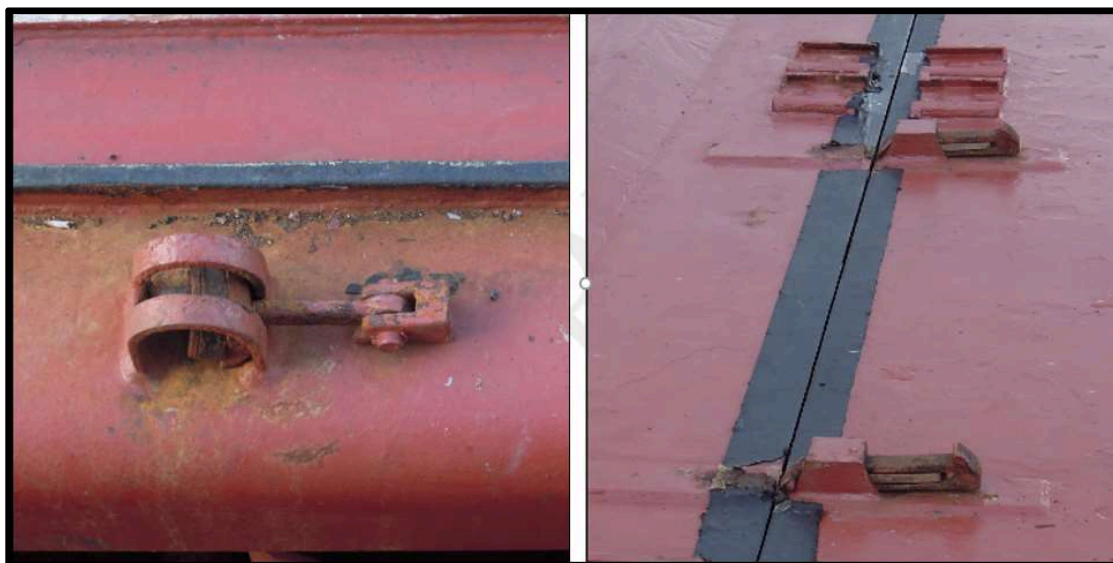
Fig 31 Hatch Covers – Dogs and Cleats

3.9.3.2 All hatch covers were found to be in place during the underwater inspection, although hatch cover No:3 was distorted upward by 60 – 80 cm in the middle. As a result, the No: 3 hatch cover was offset 10 – 20 cm to starboard. All quick acting dogs were broken, and the hatch top cleats locking the adjacent hatch covers were also broken.
